RWE NUKEM

Dalgety Bay

TR/89191/001
Issue A
March 2006
Page 1 of 22
Jack Armitage

Title: Investigation/hot spot removal at Dalgety Bay

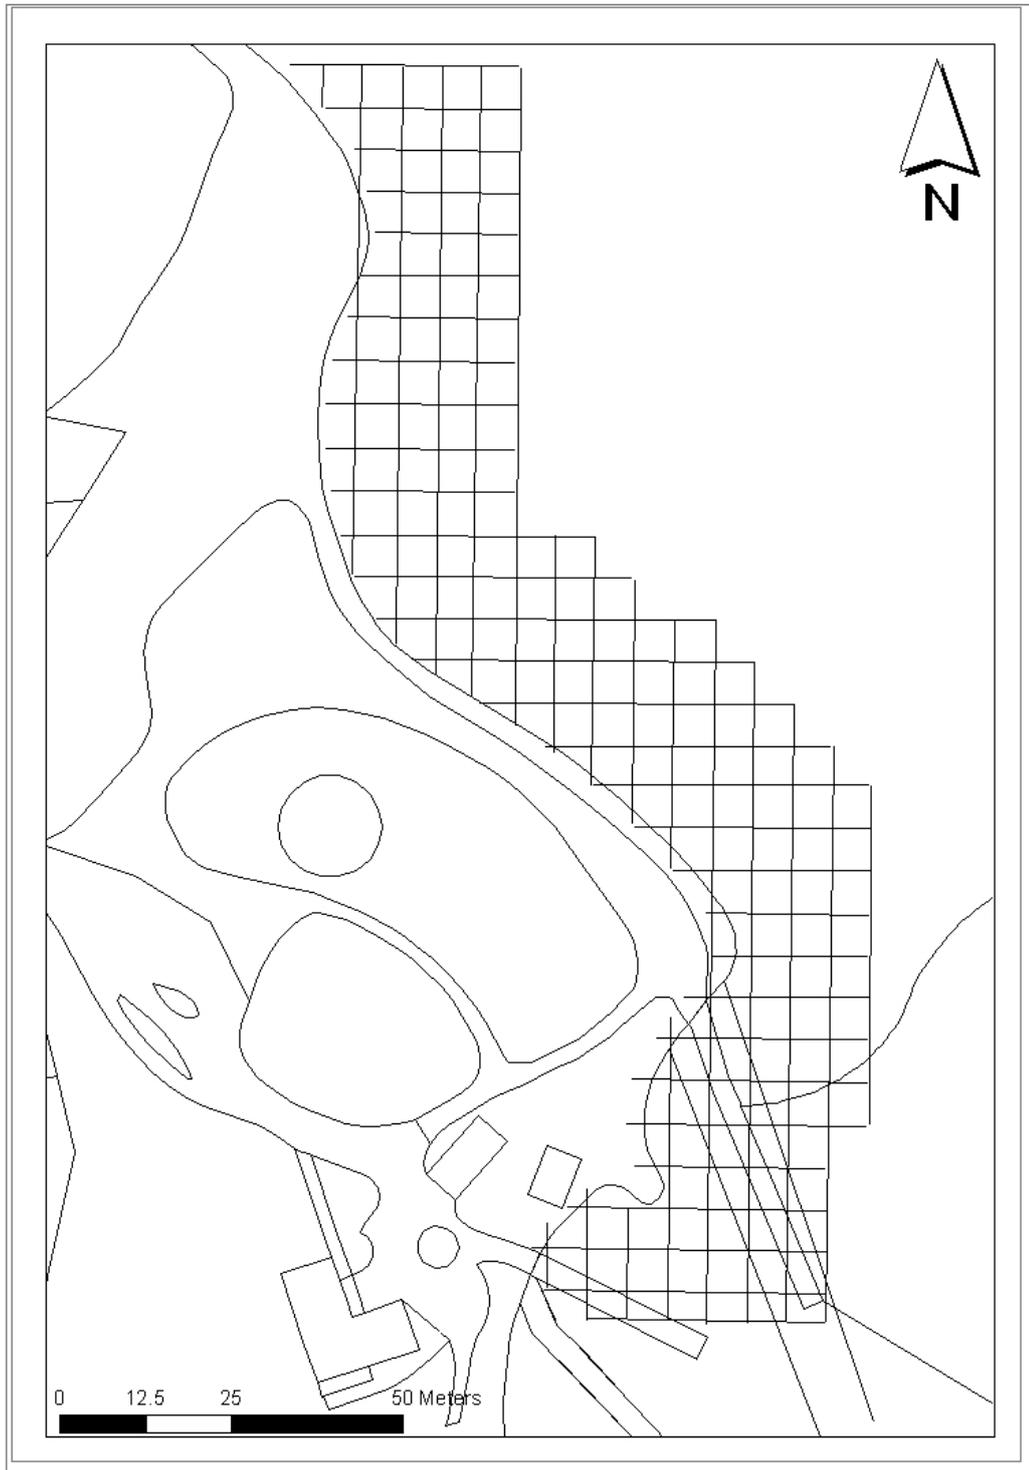
Figure 2.1 Survey grid of previous investigations. After BES/SEPA, 2005.

The investigation comprised a surface radiation survey within the survey area used during previous investigations (Figure 2.1) to identify and record the location of radioactive particles, followed by retrieval of identified particles for assay and subsequent disposal. Information obtained on the distribution and radioactivity content of particles would enable a better understanding of the radiological situation at Dalgety Bay.

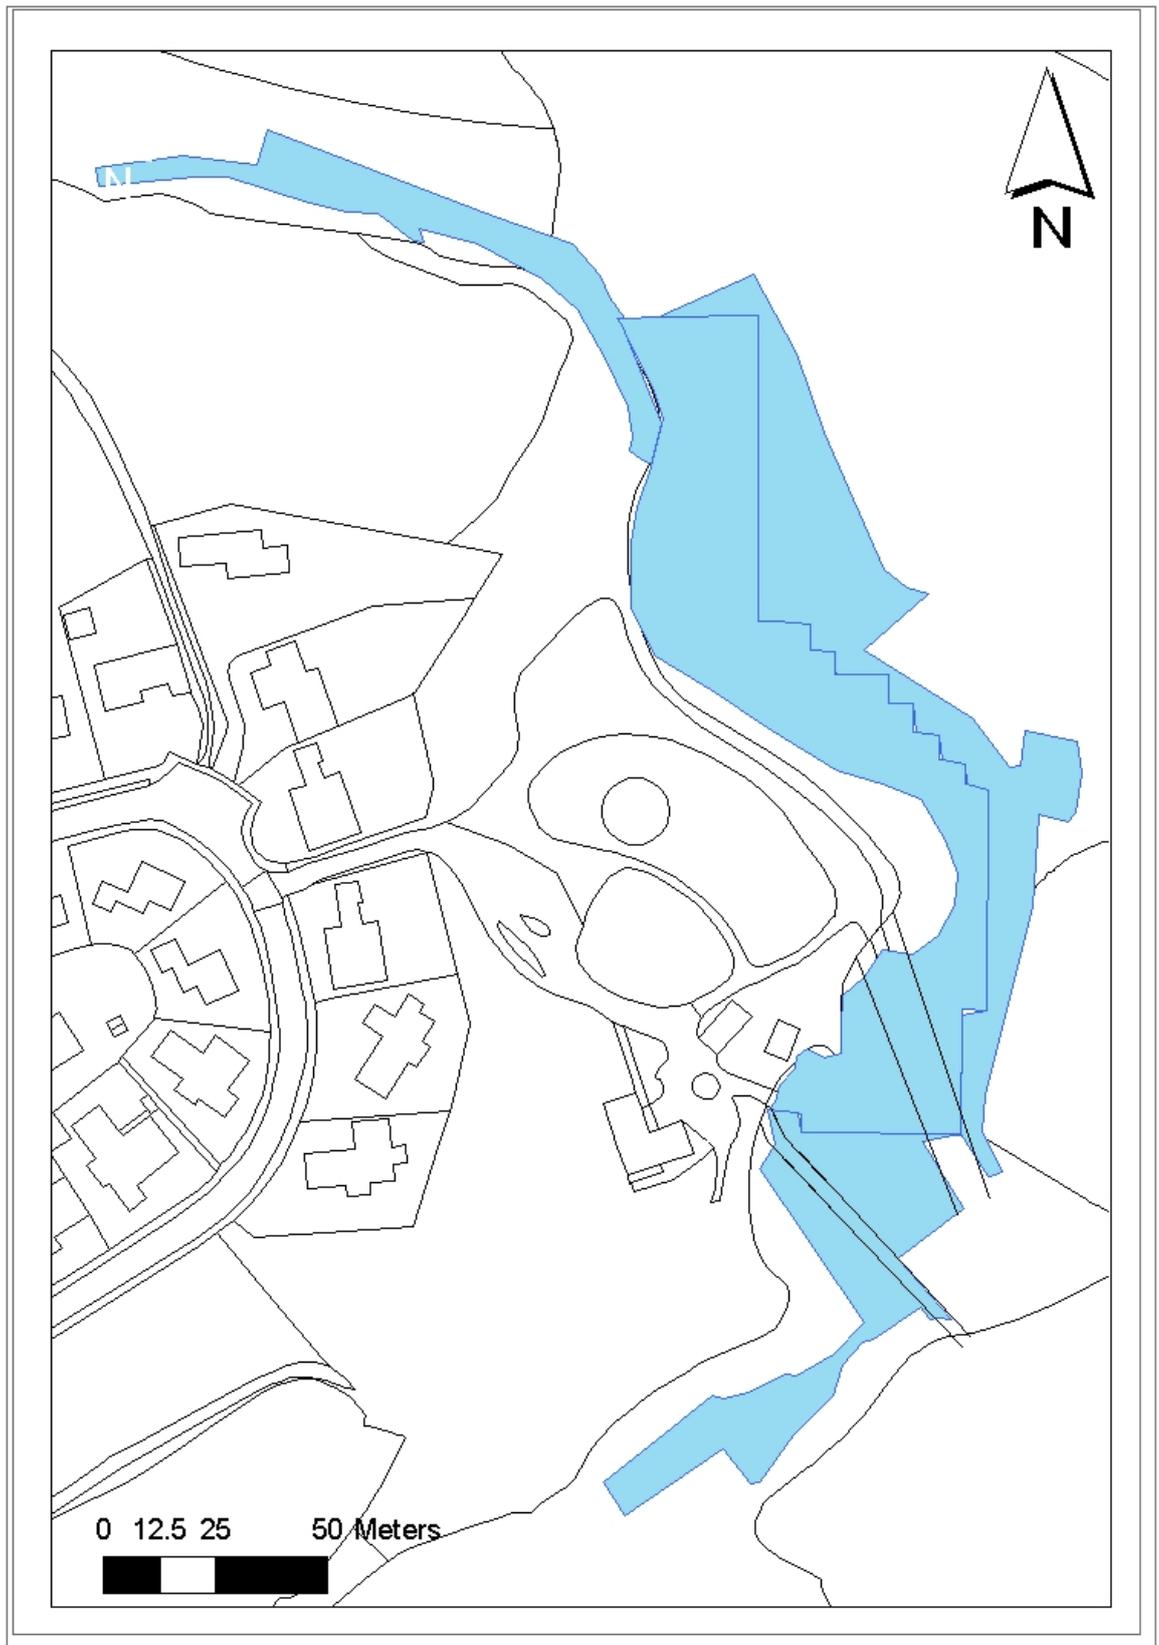
Figure 5.1 Extent of survey coverage at Dalgety Bay.
Note, total area approximately 1.1 hectares.

The initial aim of the investigation was to survey only the area subjected to previous investigation work by Babcock Engineering Services. This area amounted to approximately 5000 m². Additional areas to the north, east and south of the previously investigated area were also surveyed, which covered areas of 1200 m², 2800 m² and 2000 m² respectively. The full survey area is shown in Figure 5.1.

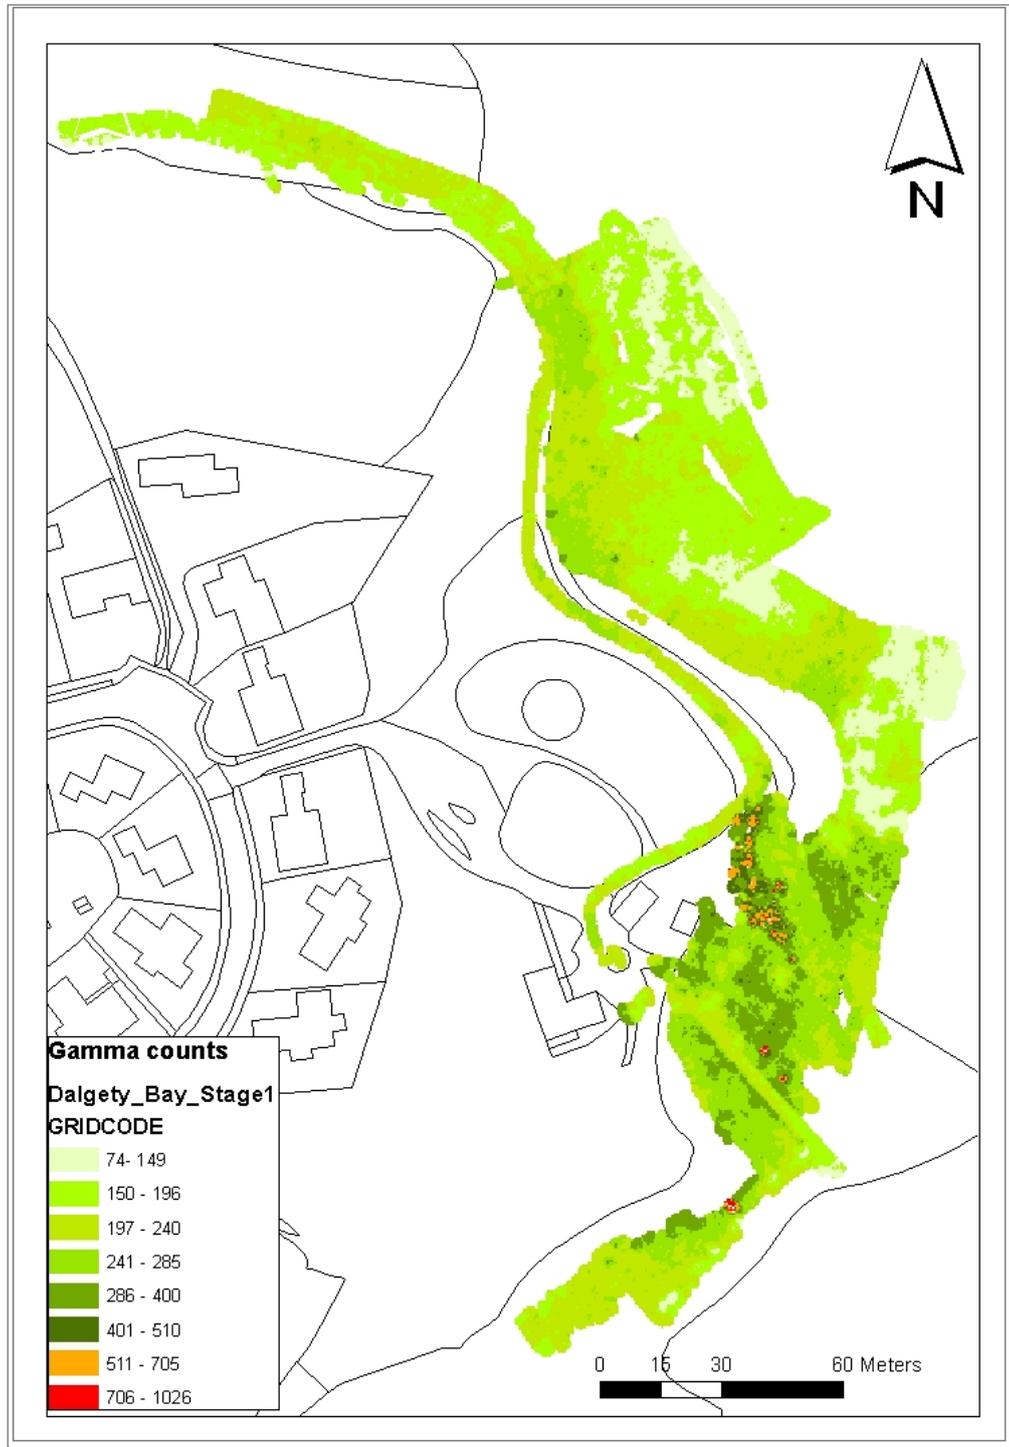
Figure 5.2 Groundhog survey plot of Dalgety Bay foreshore.

The colour radiation plot of the survey undertaken is shown below in Figure 5.2.

Identification of hotspots was undertaken by use of the colour coded plot showing radiation levels in cps. In order to assist in the decision making process the software used to plot the data (ArcView) produces classification statistics of the plotted data, (Table 5.1).

Areas which exceeded background (the mean count rate) by the largest amount were investigated first as the highest priority targets. For example areas in which count rates exceeded 510cps (as shown on Figure 5.2).

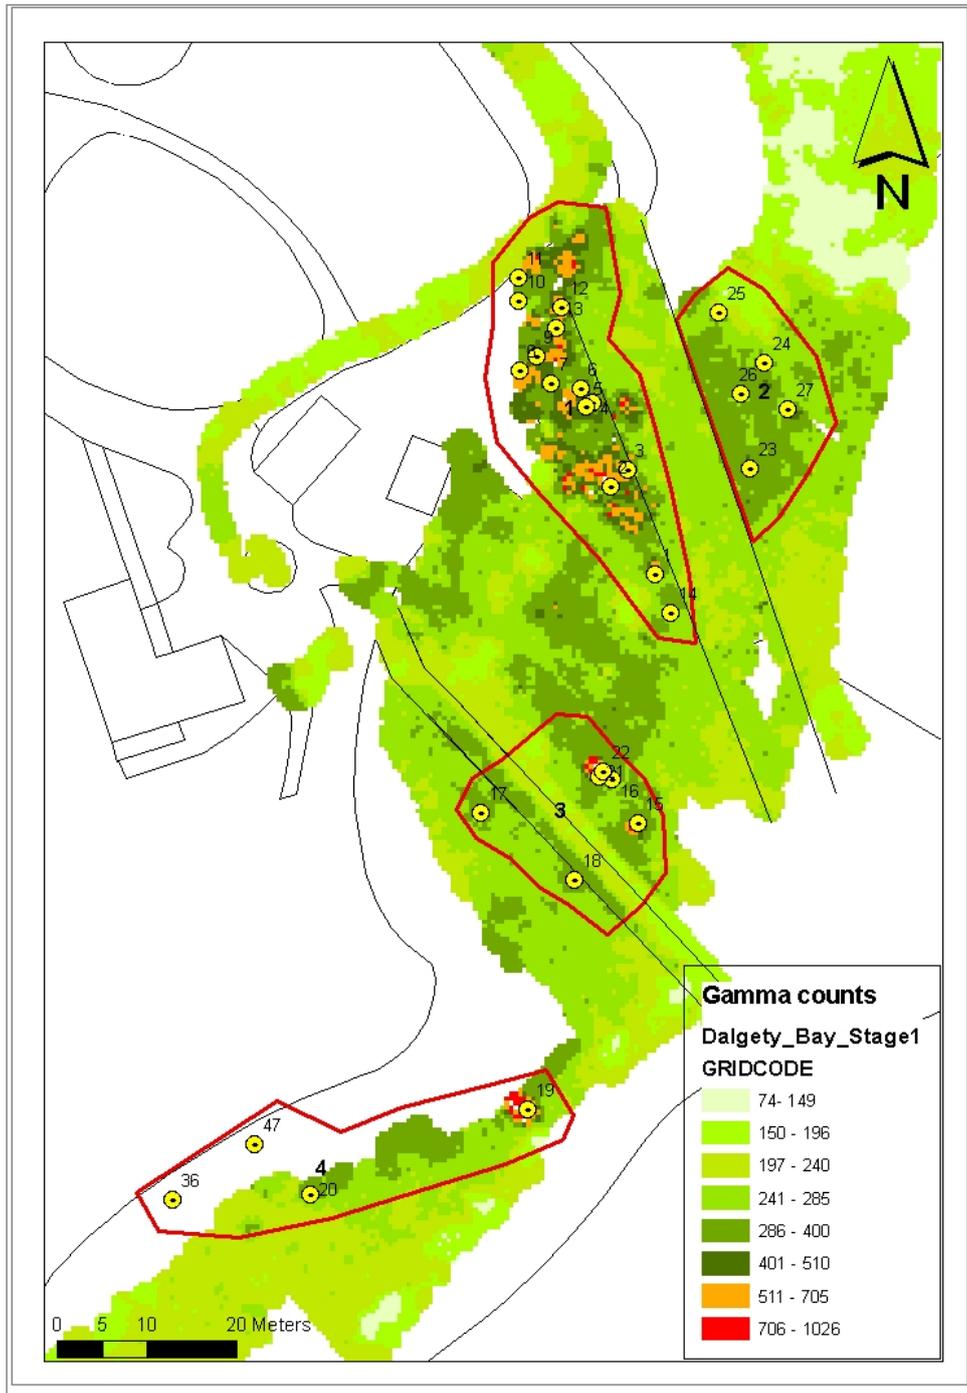
Four main hotspot clusters were identified during the survey (Figure 5.3) and these areas are described below.

Figure 5.3 Hotspot clusters and locations at Dalgety Bay.

This area is approximately 600m² and contained 14 hotspot localities in a relatively confined area immediately west of the northern-most slipway. The upper reaches of the area did not appear to be submerged during high tides as small boats were tied up at the location. Excavations in the area indicated a higher proportion of dark ash type residue and clinker.

This area is approximately 300m² and contained 5 hotspot localities. The area of interest is immediately west of the northern-most slipway and appeared to be affected by wave action/erosion. Large quantities of imported rock had been placed at the top of the foreshore for reinforcement.

This area is approximately 350m² and contained 6 hotspot localities and is situated around the mid and southern slipways.

This area is approximately 470m² and contained 4 hotspot localities, two of which were located on the foreshore and two within the cliff section. The foreshore was much rockier than other parts of the survey area and numerous fragments of metallic items were identified during the survey.

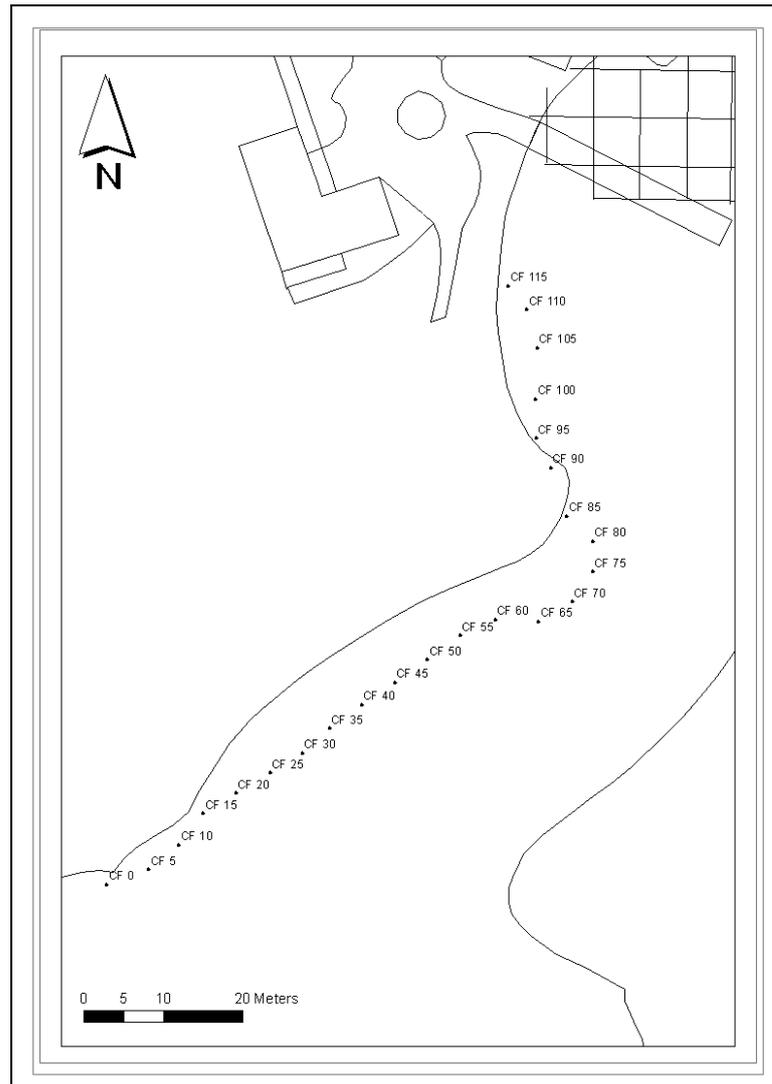
Figure 7.1 Extent of the cliff survey.
Note labelling denotes (CF), Cliff face 5 metre intervals along cliff edge.

The cliff face describes an area of land south of the main survey area which is believed to comprise made ground arising from Donibristle air base (Figure 7.1).

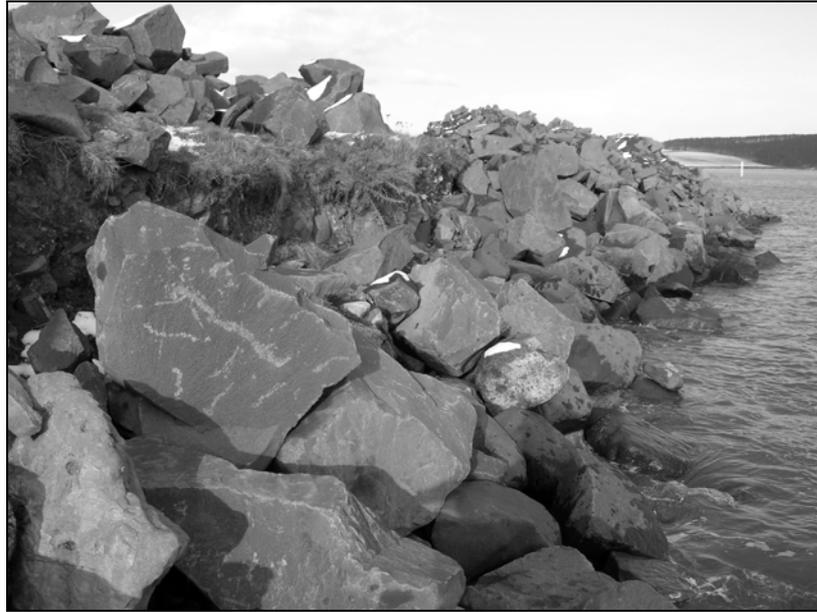
Much of the section was obscured by imported stone that had been recently delivered for use as rock armour (Figure 7.2). Therefore, a full survey of the cliff was not possible.

Figure 7.2 Rock armour obscuring a large proportion of the cliff section.
Photograph taken looking north east along edge of cliff section.

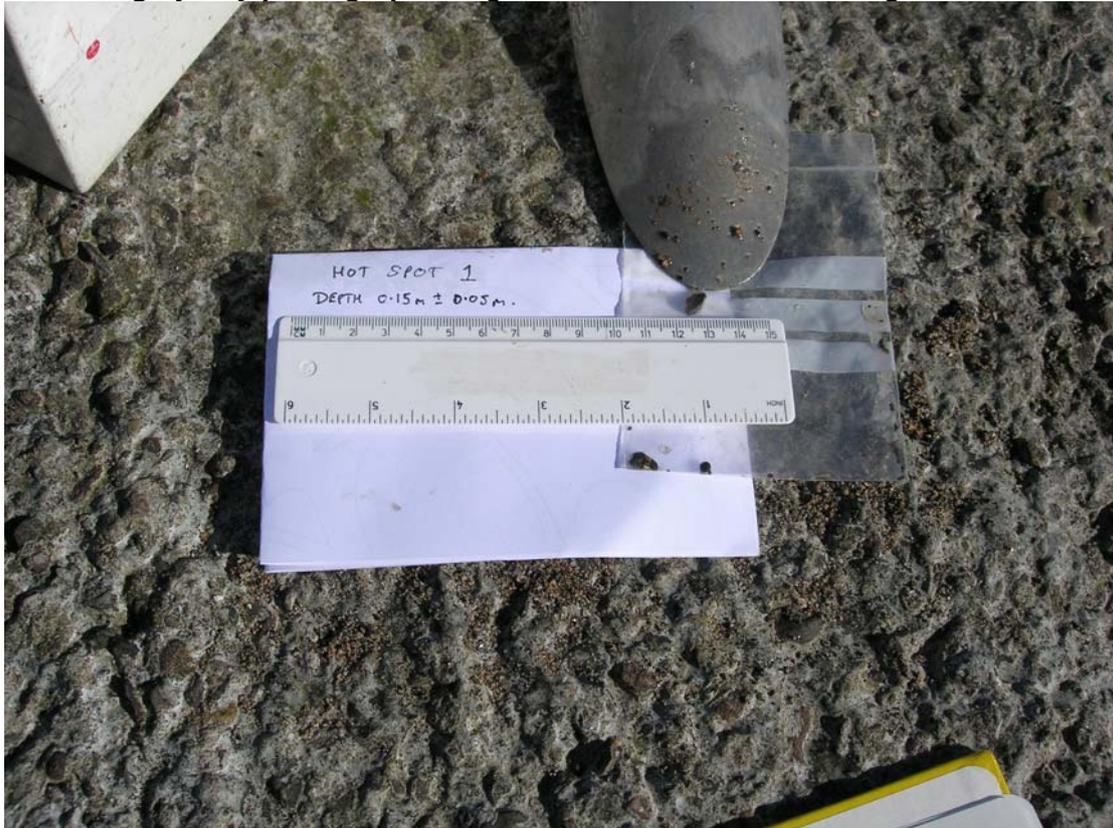
Hotspot 1 (by tip of trowel)

HS_1 was a medium gravel sized piece of clinker found at a depth of 0.1m. The maximum dose rates at contact and at 10cm were 125 and 5 μ Sv/h respectively. Direct 44B probe readings were at full scale deflection (>5000cps).

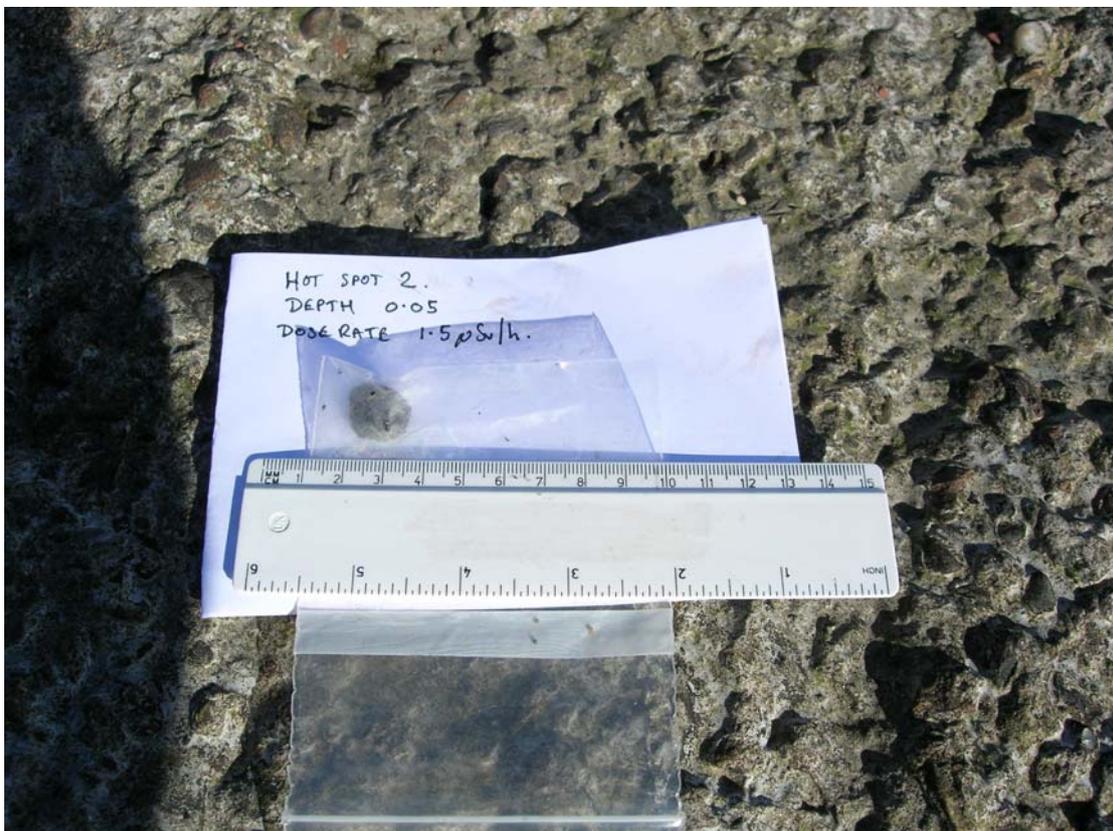
Hotspot 2

HS_2 was a fragment of dark clinker material of coarse gravel size. Direct 44B probe readings of 700cps were recorded and maximum dose rates at contact and 10cm were 1.5 and 0.15 μ Sv/h respectively. Note that the dose rate measured at 10cm was effectively at background level.

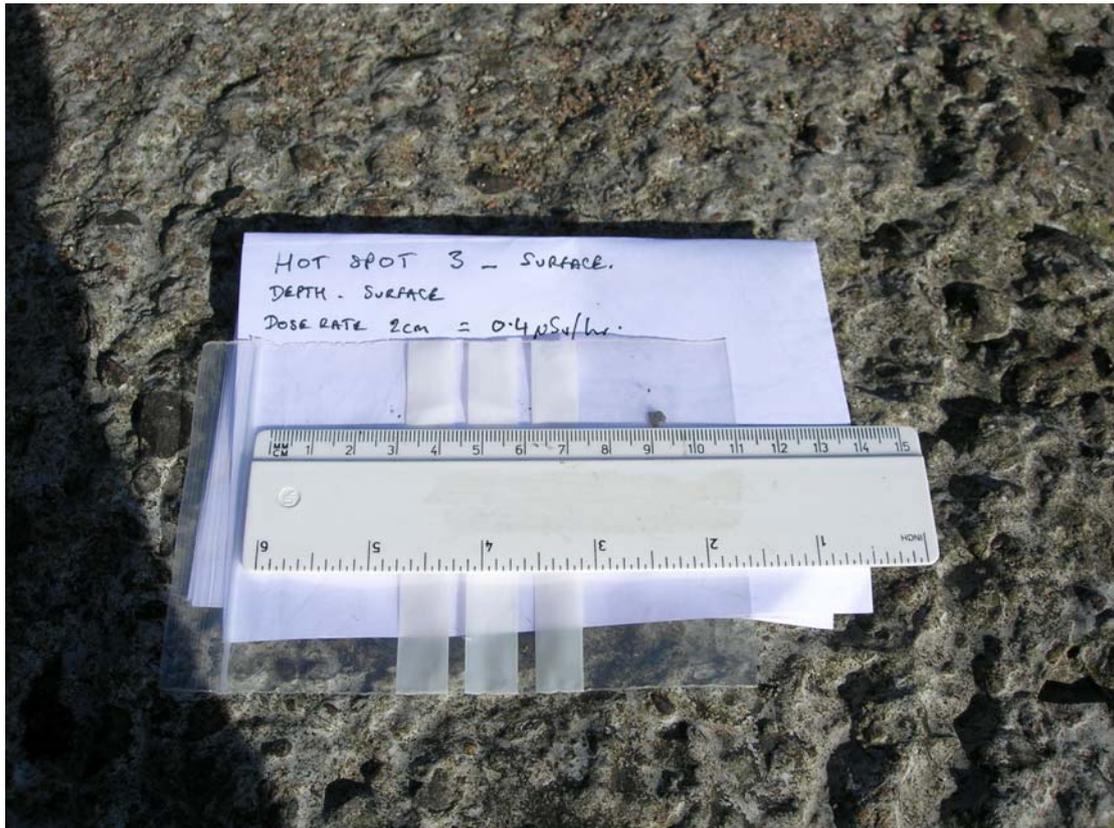
Hotspot 3 at surface

The first item at this location was isolated at the surface and comprised a fine gravel sized fragment of dark clinker. Maximum dose rates at contact and 10cm were 0.4 and 0.15 μ Sv/h respectively. Maximum 44B probe readings were 500cps.

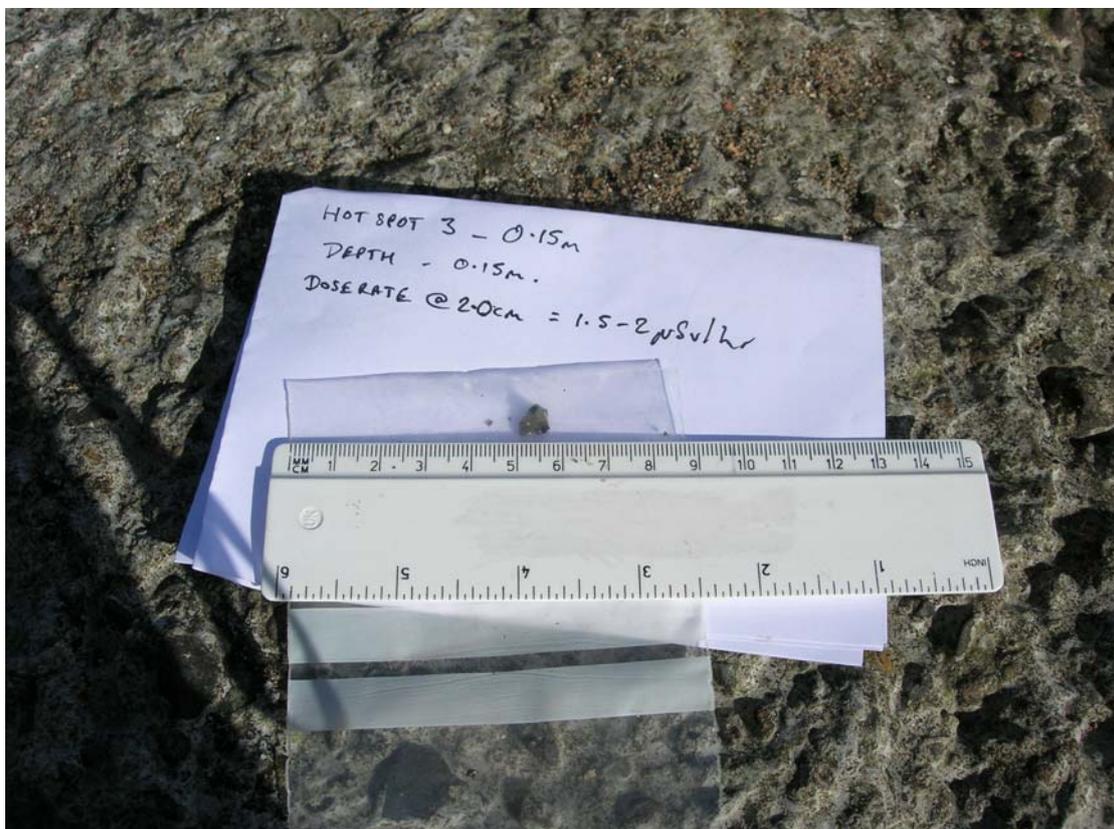
Hotspot 3 at 0.15m

The second item located comprised a medium gravel sized clinker fragment and was found at a depth of 0.15m. Direct 44B probe readings were up to 1000cps and maximum dose rates at contact and 10cm were 2 and 0.5 μ Sv/h respectively.

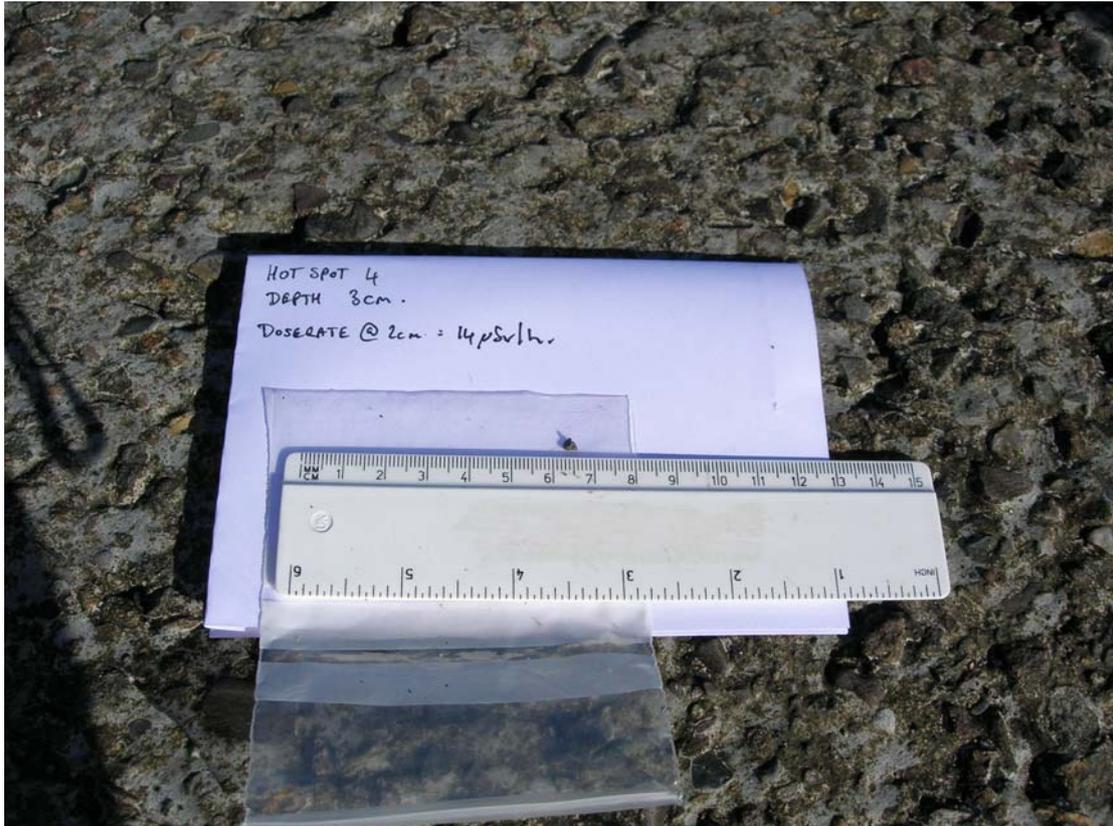
Hotspot 4

HS_4 was a fine gravel sized piece of clinker located at 0.03m. Maximum dose rates at contact and 10cm were 16 and 0.6 μ Sv/h respectively and direct 44B readings exceeded 5000cps.

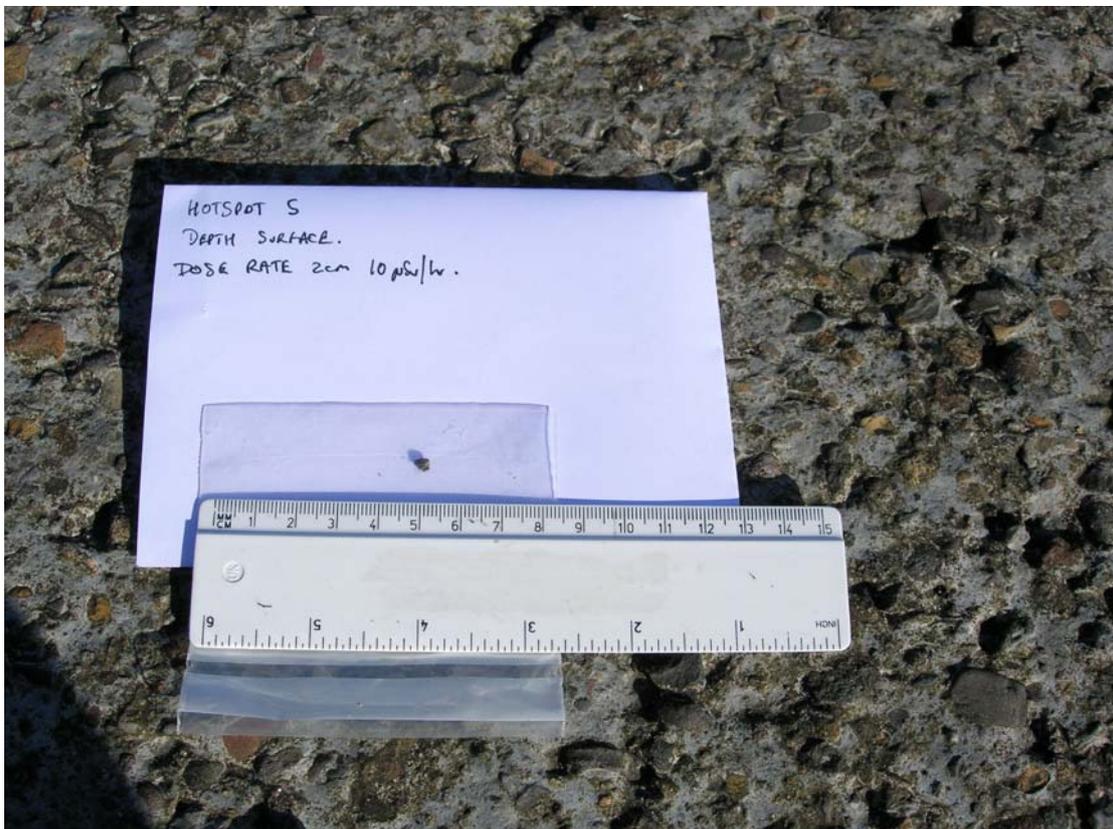
Hotspot 5

HS_5 was a fine gravel sized piece of clinker located on the surface of the shoreline. Maximum dose rates at contact and 10cm were 10 and 1 μ Sv/h respectively and direct 44B readings exceeded 5000cps.

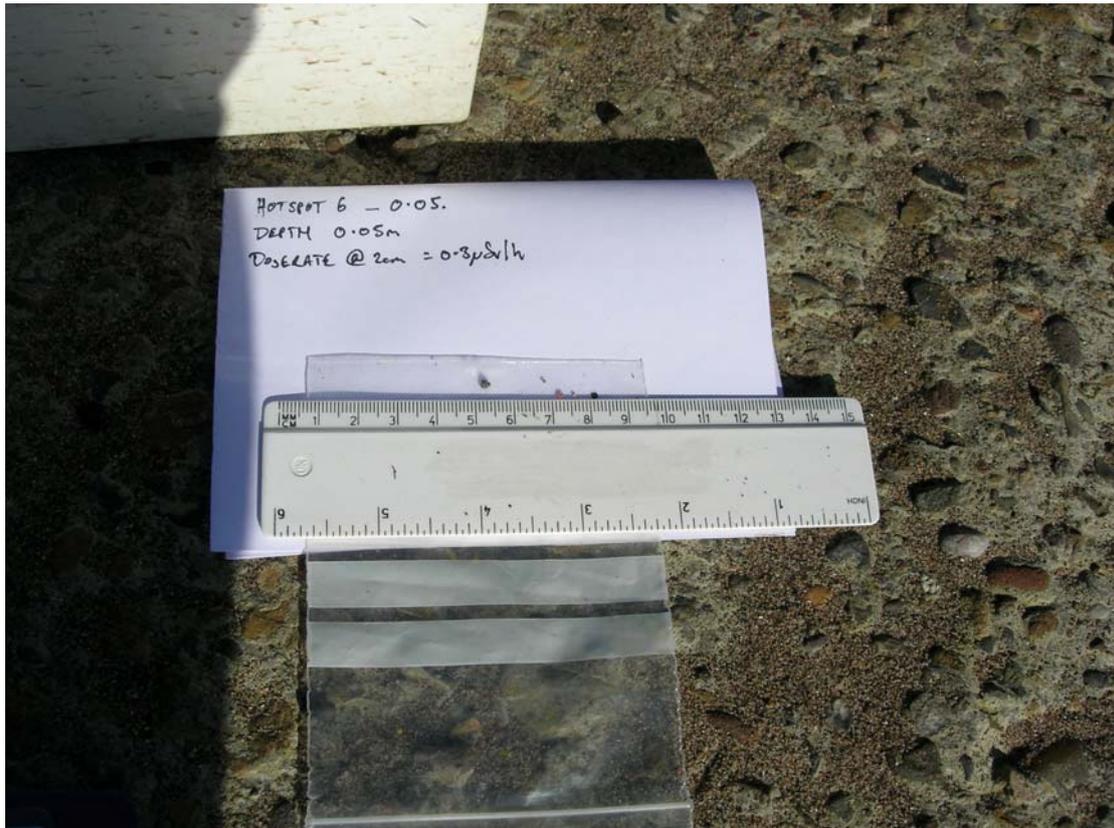
Hotspot 6 at 0.05m

The first item found at the location was fine gravel sized and located at a depth of 0.05m. Direct 44B probe readings of 300 cps were recorded. Maximum dose rates at contact and 10cm were 0.3 and 0.15 μ Sv/h respectively.

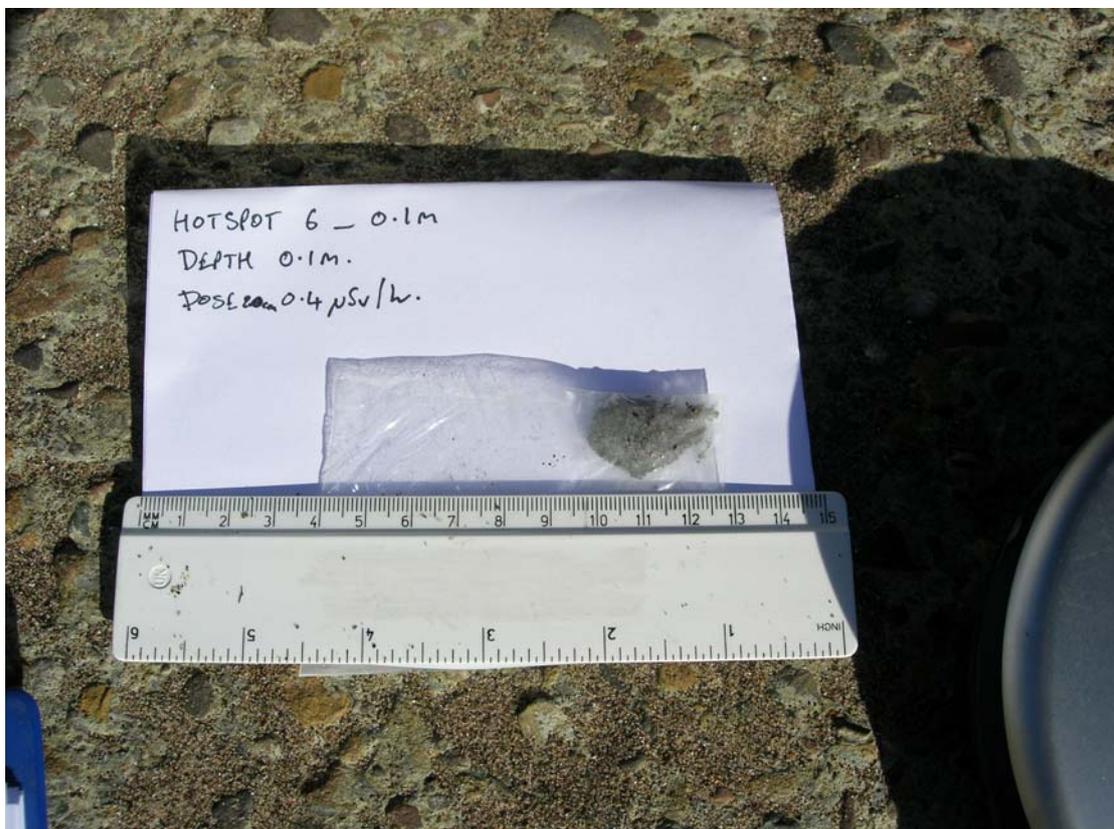
Hotspot 6 at 0.1m

The second item was located at a depth of 0.1m and comprised a coarse gravel sized fragment of clinker. Maximum dose rates at contact and 10cm were 0.4 and 0.15 μ Sv/h respectively and direct 44B probe readings were 300cps.

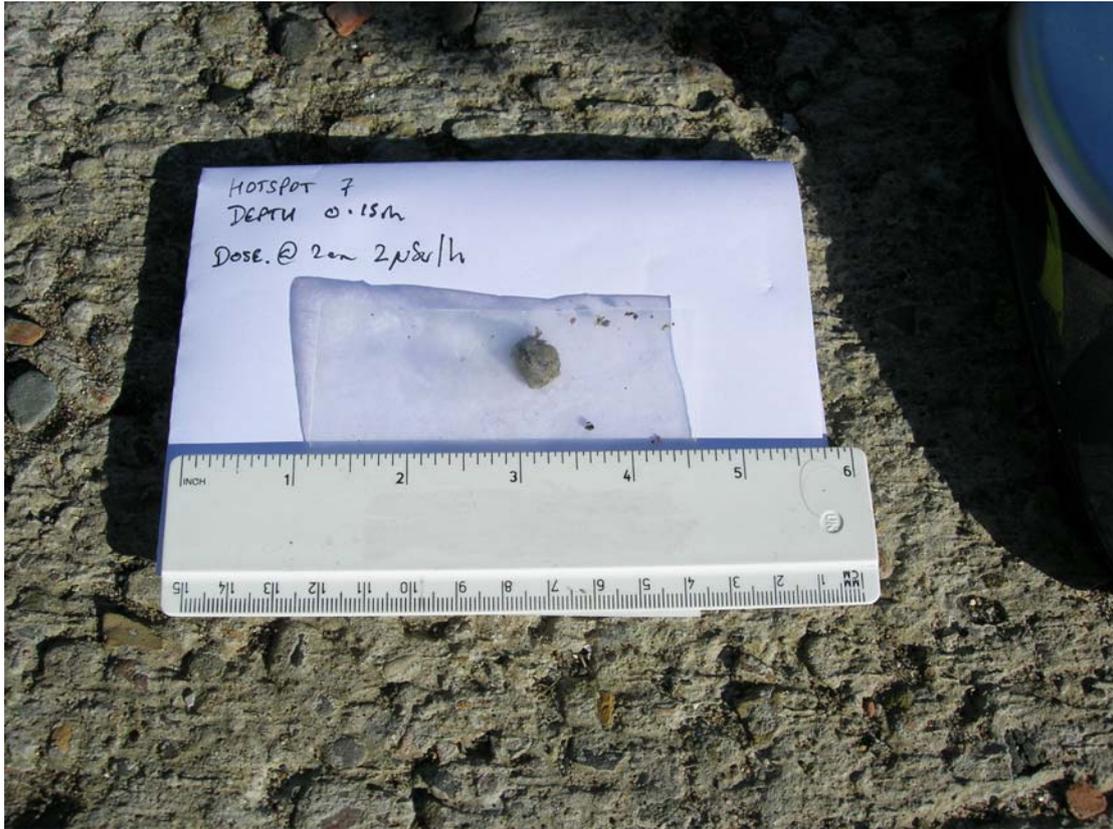
Hotspot 7

HS_7 was found at a depth of 0.15m and comprised a medium gravel sized fragment of clinker. 44B probe readings were 1500cps and maximum dose rates at contact and 10cm were 2 and 0.15 μ Sv/h respectively.

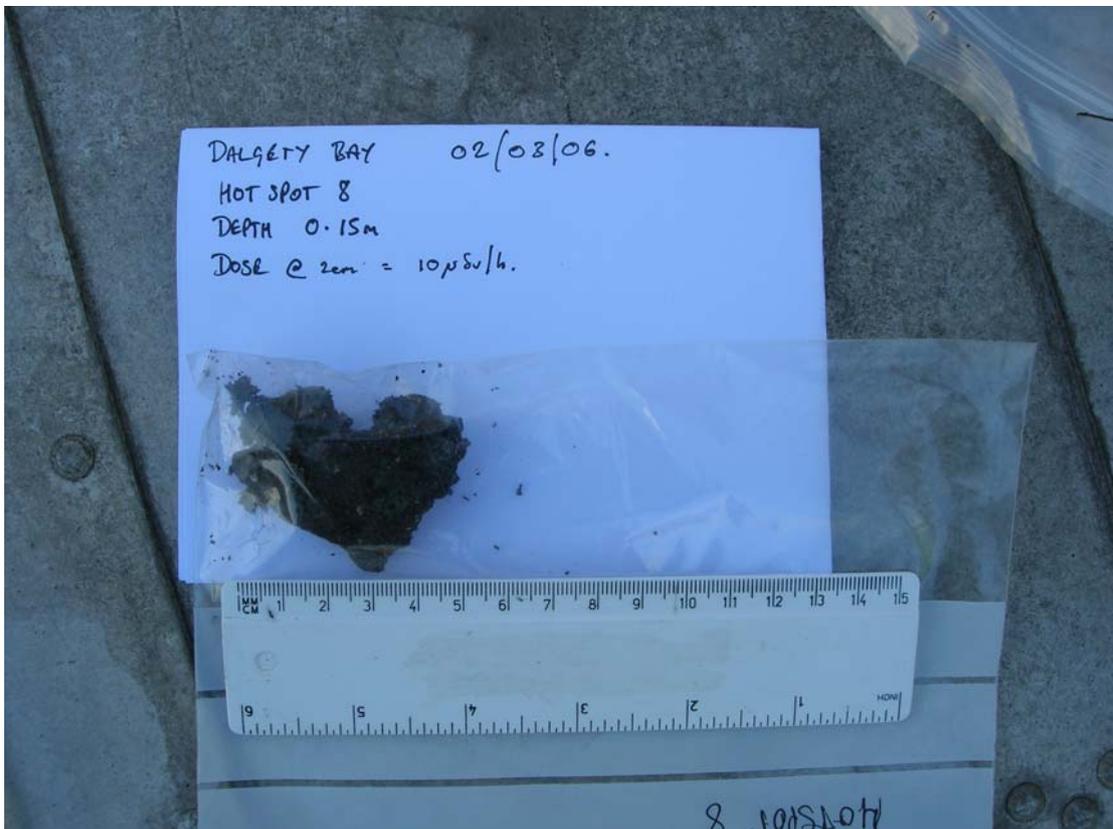
Hotspot 8

HS_8 was located at 0.15m and comprised a coarse gravel sized fragment of clinker. Maximum dose rates at contact and 10cm were 10 and 1.5 μ Sv/h respectively whilst direct 44B readings of 2000cps were recorded.

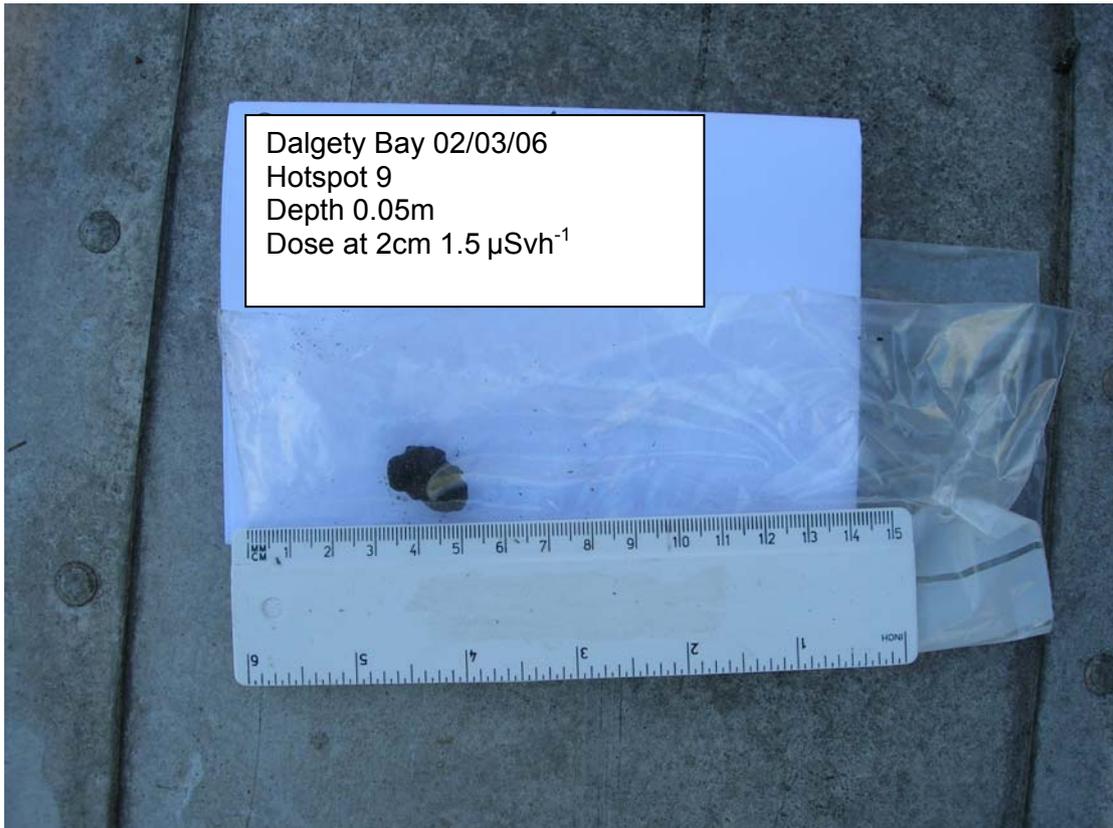
Hotspot 9

HS_9 was a coarse gravel sized fragment of clinker found at 0.05m. Direct 44B probe readings were 500cps and maximum dose rates at contact and 10cm were 1.5 and 0.6 μ Sv/h respectively.

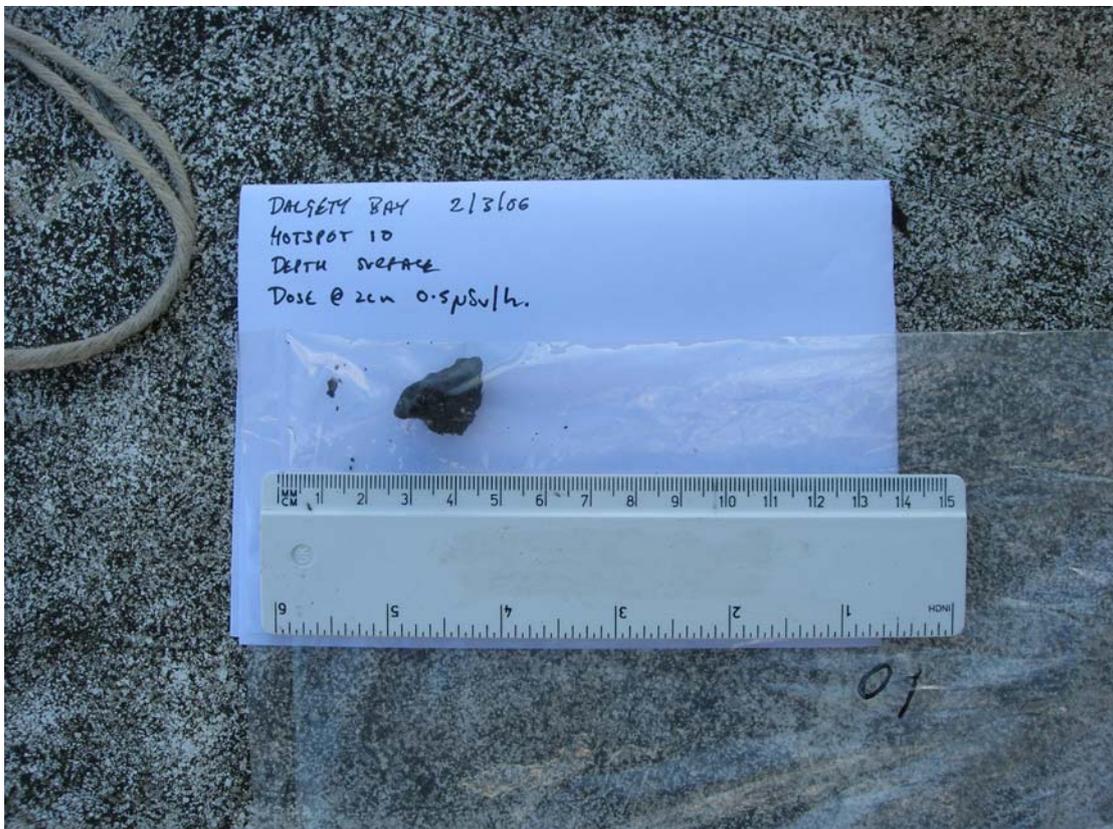
Hotspot 10

Located at the surface, HS_10 comprised a medium gravel sized clinker fragment. Maximum dose rates at contact and at 10cm were 0.5 and 0.15 μ Sv/h respectively. 44B probe readings of up to 500cps were recorded.

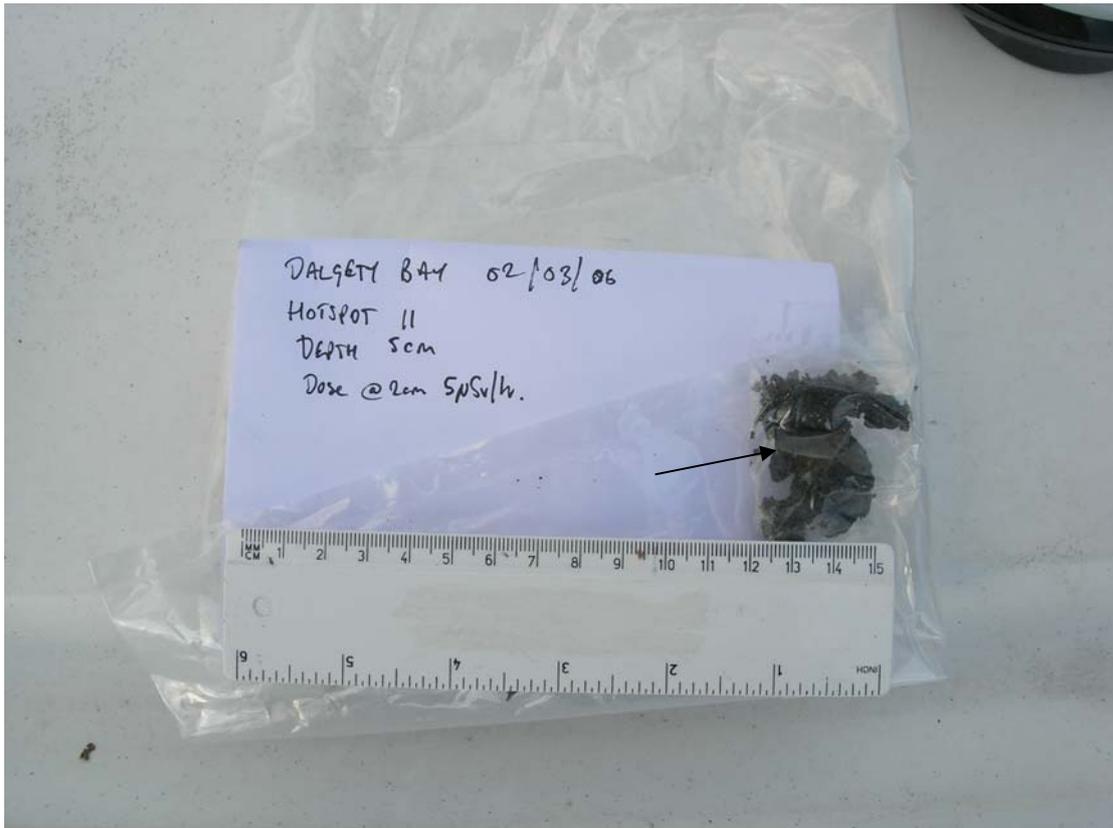
Hotspot 11

A medium gravel sized fragment of clinker was excavated at a depth of 0.05m. Direct 44B probe readings were 1500cps and maximum dose rates at contact and at 10cm were 5 and 0.7 μ Sv/h respectively.

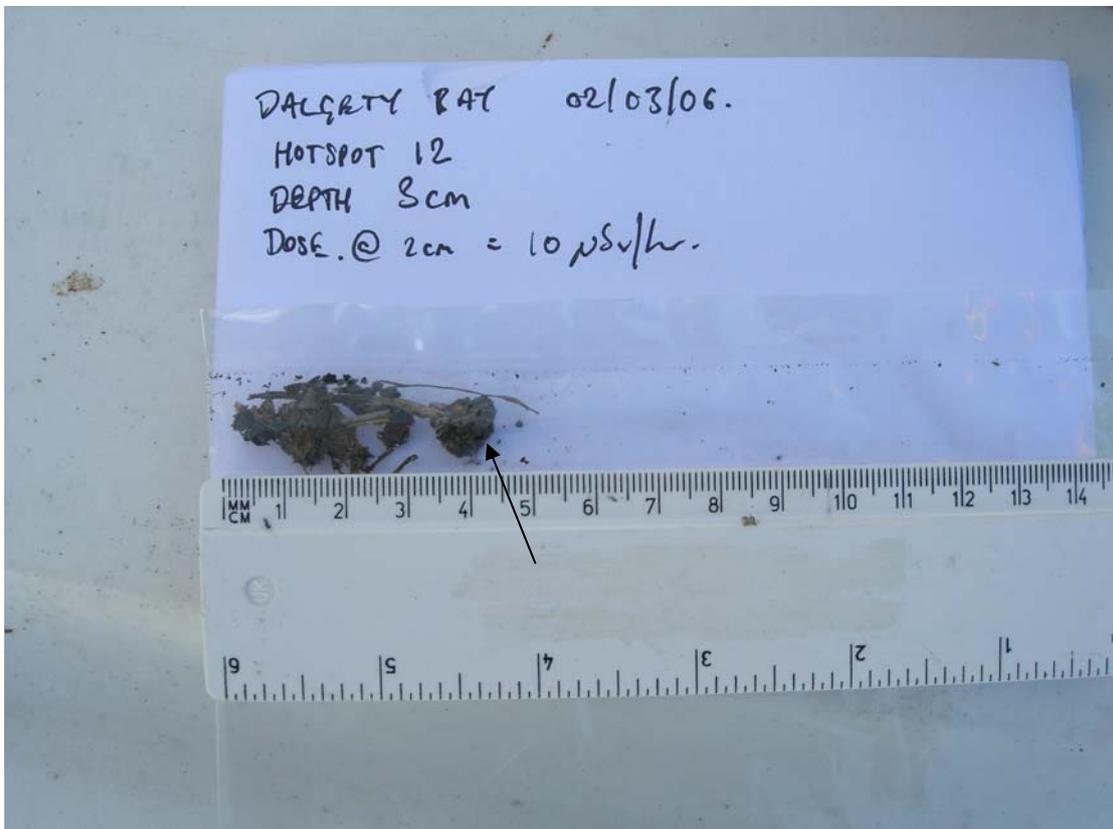
Hotspot 12

HS_12 was a medium gravel sized fragment of clinker found at 0.03m. Direct 44B probe readings were 1500cps and maximum dose rates at contact and at 10cm were 10 and 0.2 μ Sv/h respectively.
