RWE NUKEM

Dalgety Bay

TR/89191/001
Issue A
March 2006
Page 1 of 22
Jack Armitage

Title: Investigation/hot spot removal at Dalgety Bay

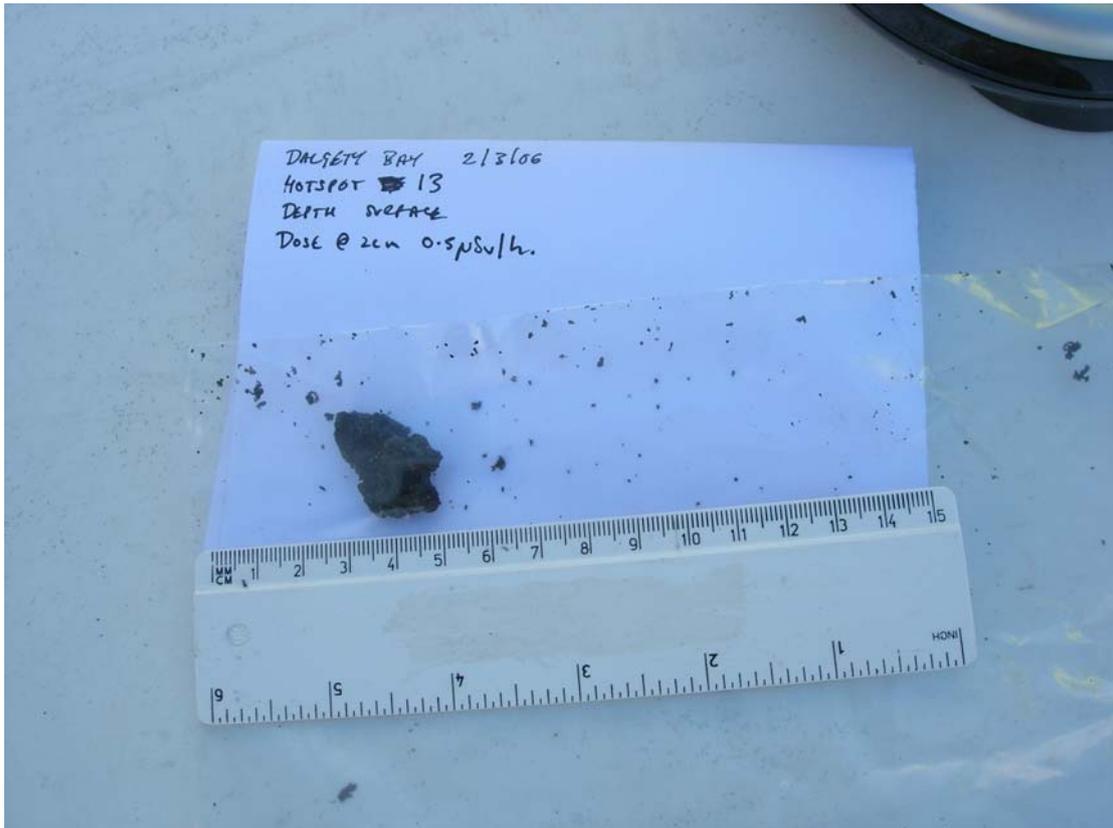
Hotspot 13

HS_13 was located at 0.075m and comprised a coarse gravel sized fragment of clinker. Maximum dose rates at contact and at 10cm were 0.5 and 0.15 μ Sv/h respectively whilst direct 44B readings of 300cps were recorded.

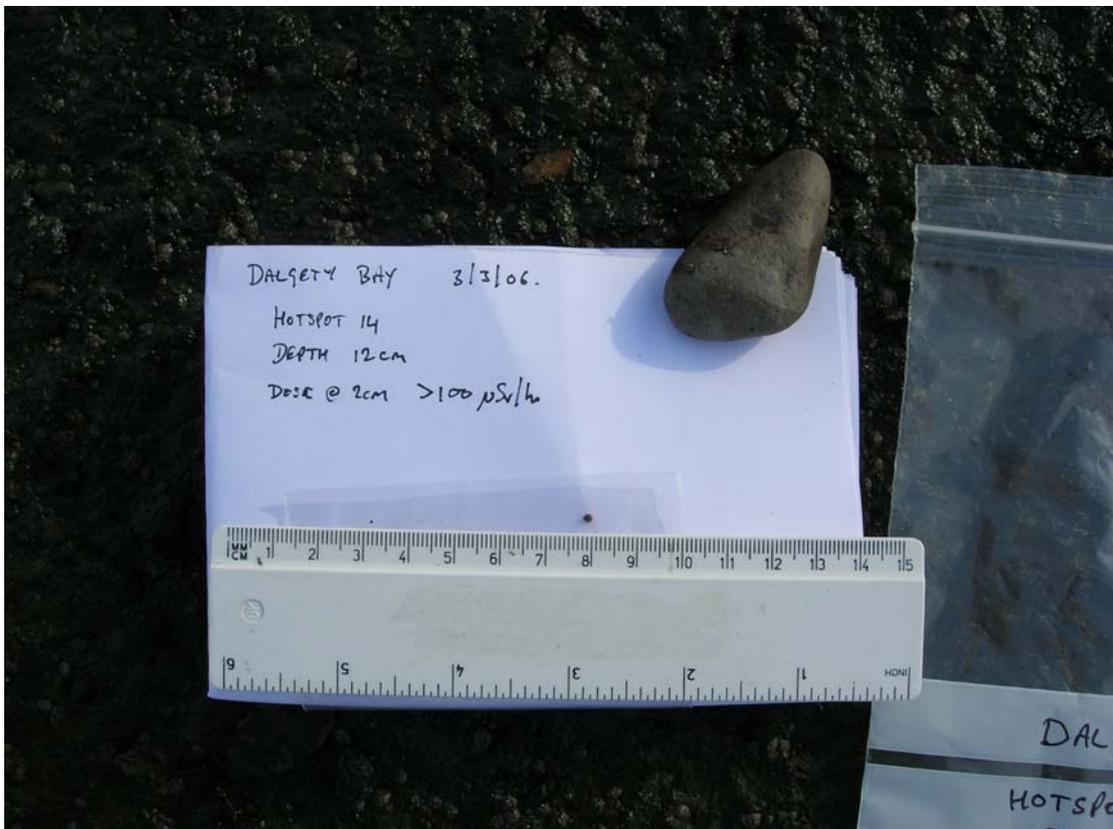
Hotspot 14

HS_14 was a coarse sand sized fragment located at 0.12m. Direct 44B probe readings exceeded 5000cps and maximum dose rates at contact and at 10cm were 125 and 5 μ Sv/h respectively.

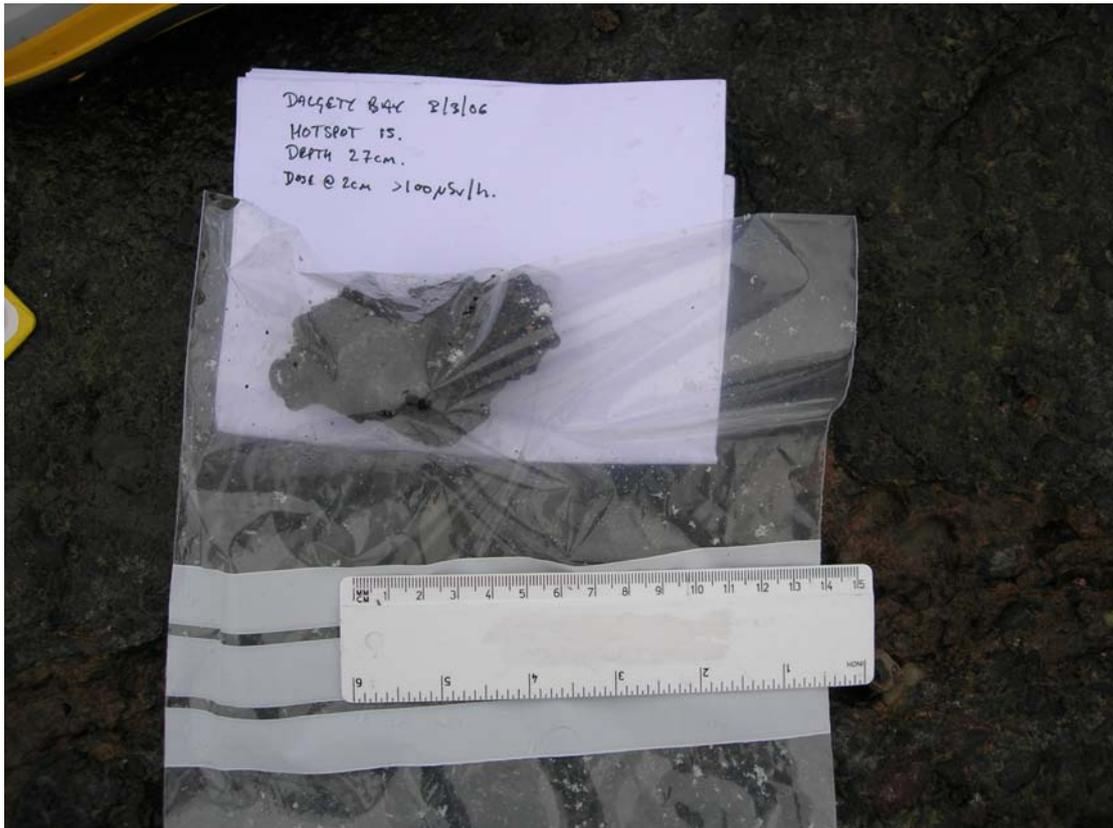
Hotspot 15

HS_15 comprised a cobble sized piece of clinker found at 0.27m. Direct 44B probe readings exceeded 5000cps and maximum dose rates at contact and at 10cm were 250 and 10 μ Sv/h respectively.

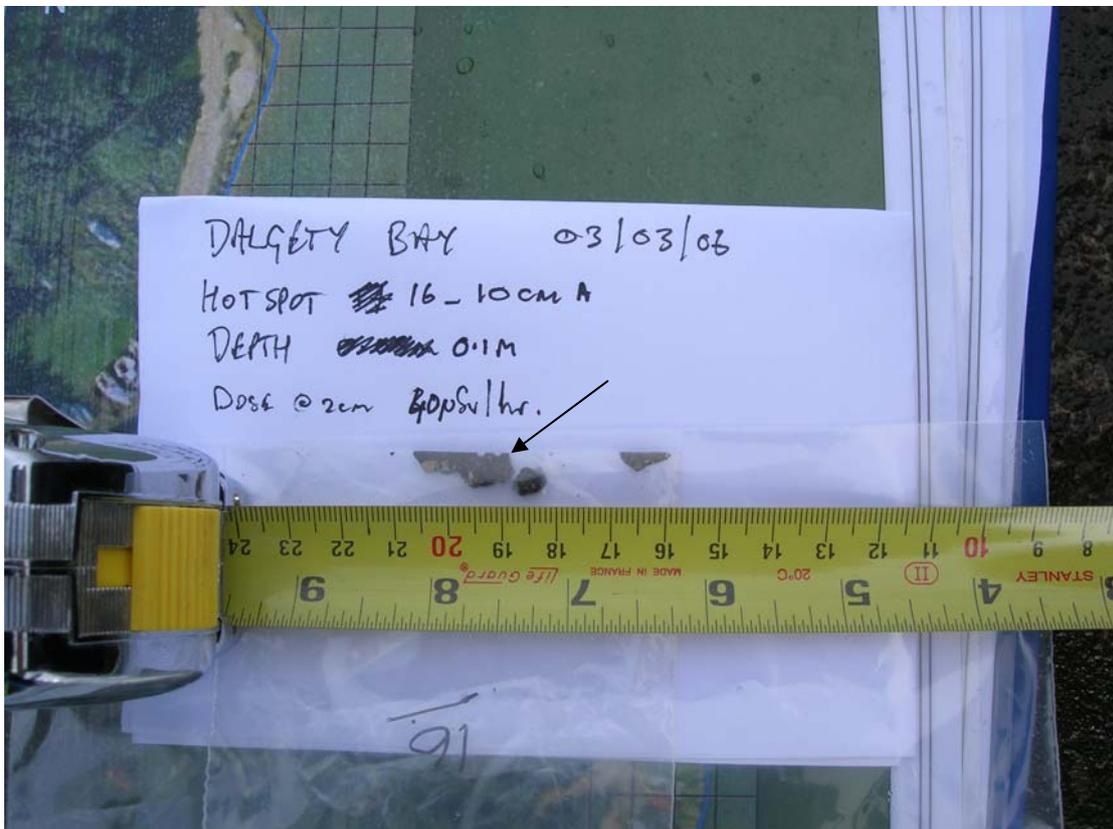
Hotspot 16 0.1m_A

The first item was found at 0.1m and comprised a fine gravel sized fragment of clinker. Maximum dose rates at contact and at 10cm were 40 and 3 μ Sv/h respectively and direct 44B probe readings exceeded 5000cps.

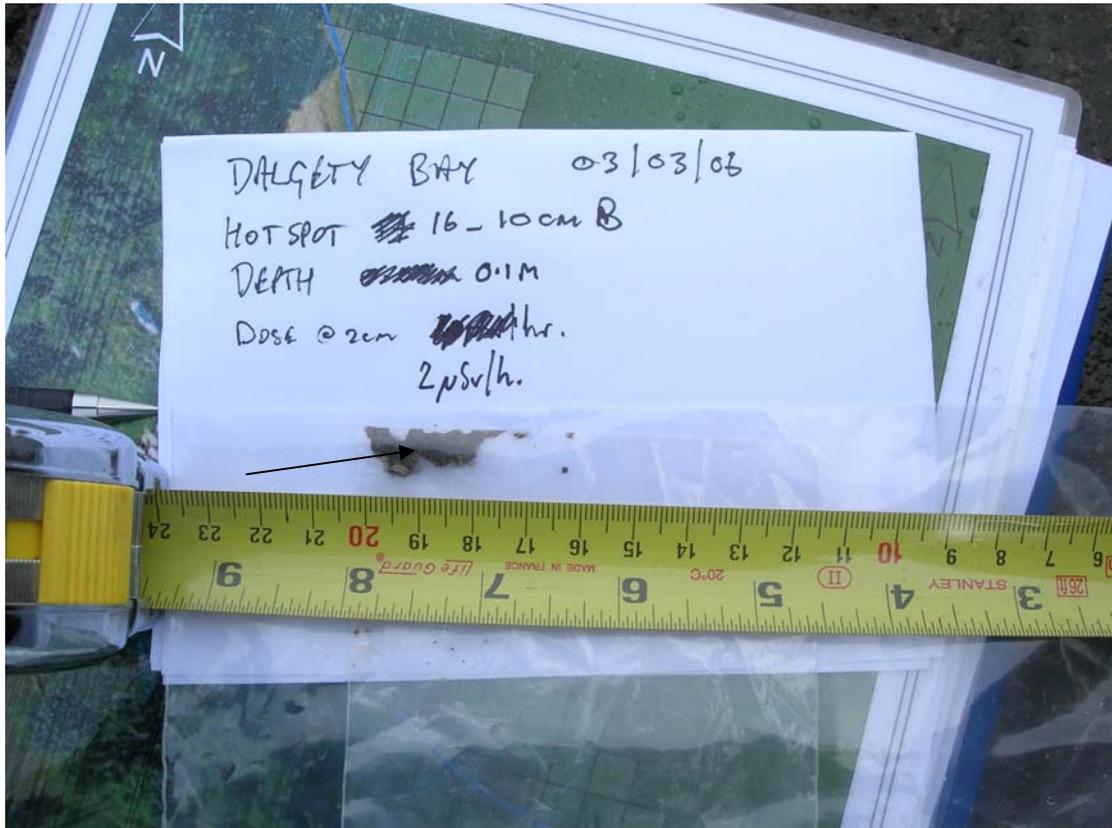
Hotspot 16 0.1m_B

The second artefact was also located at 0.1m and was also fine gravel sized. Direct 44B probe measurements were 2000cps and maximum dose rates at contact and at 10cm were 2 and 0.5 μ Sv/h respectively.

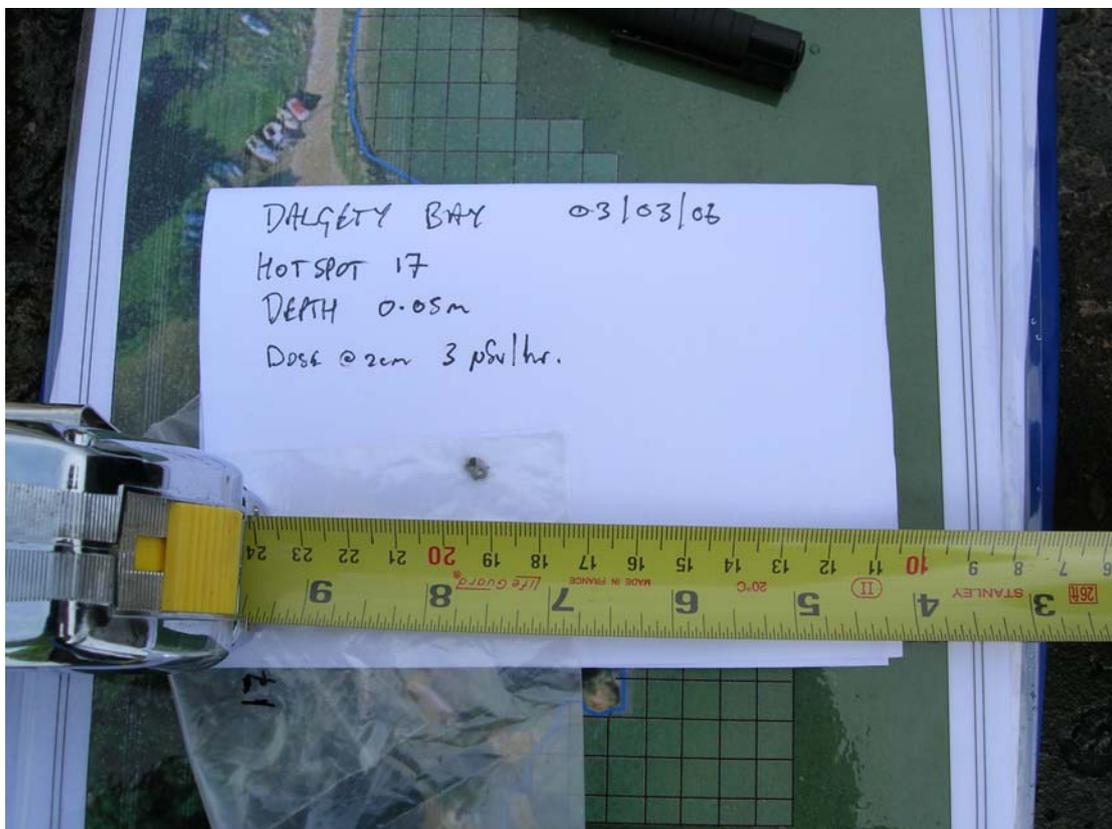
Hotspot 17

HS_17 comprised a fine gravel sized fragment of clinker which was found at a depth of 0.05m. Maximum dose rates at contact and at 10cm were 3 and 0.4 μ Sv/h respectively. Direct 44B probe readings were measured at 2000cps.

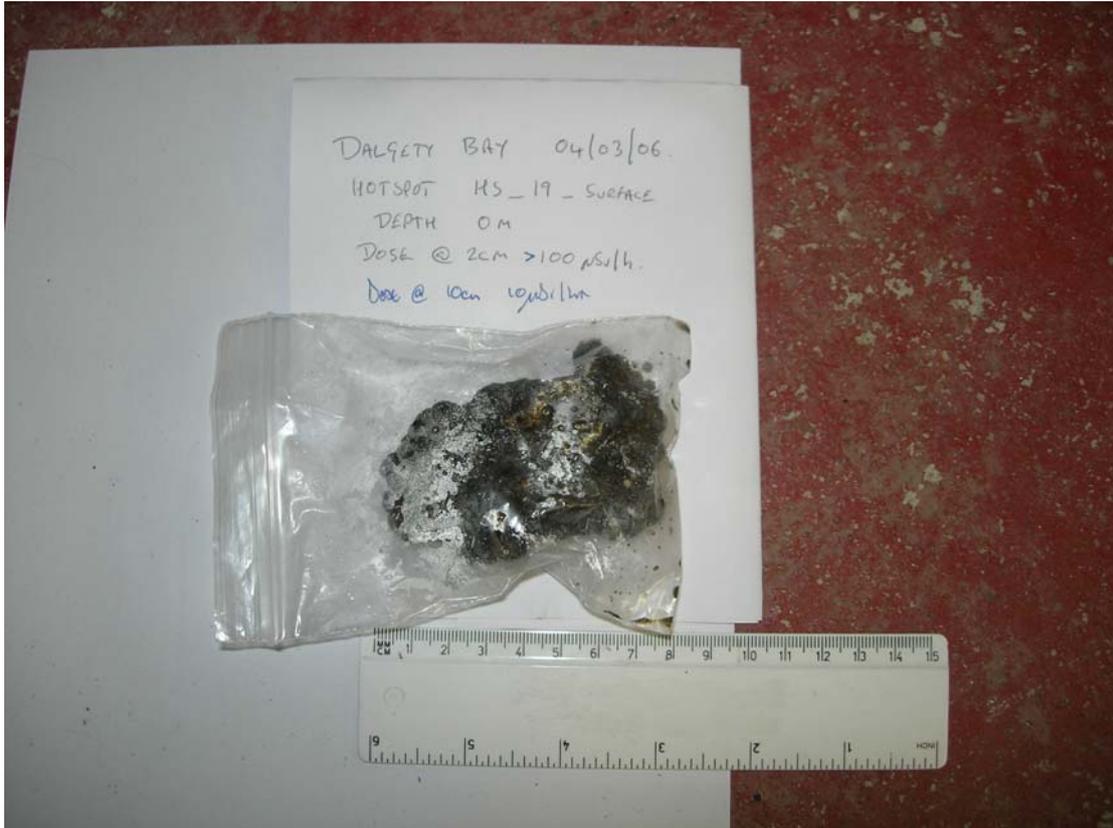
Hotspot 19

A cobble sized piece of clinker was located at the surface of the foreshore with a maximum 44B probe reading of >5000cps. Maximum dose rates at contact and at 10cm were 200 and 8 μ Sv/h respectively.

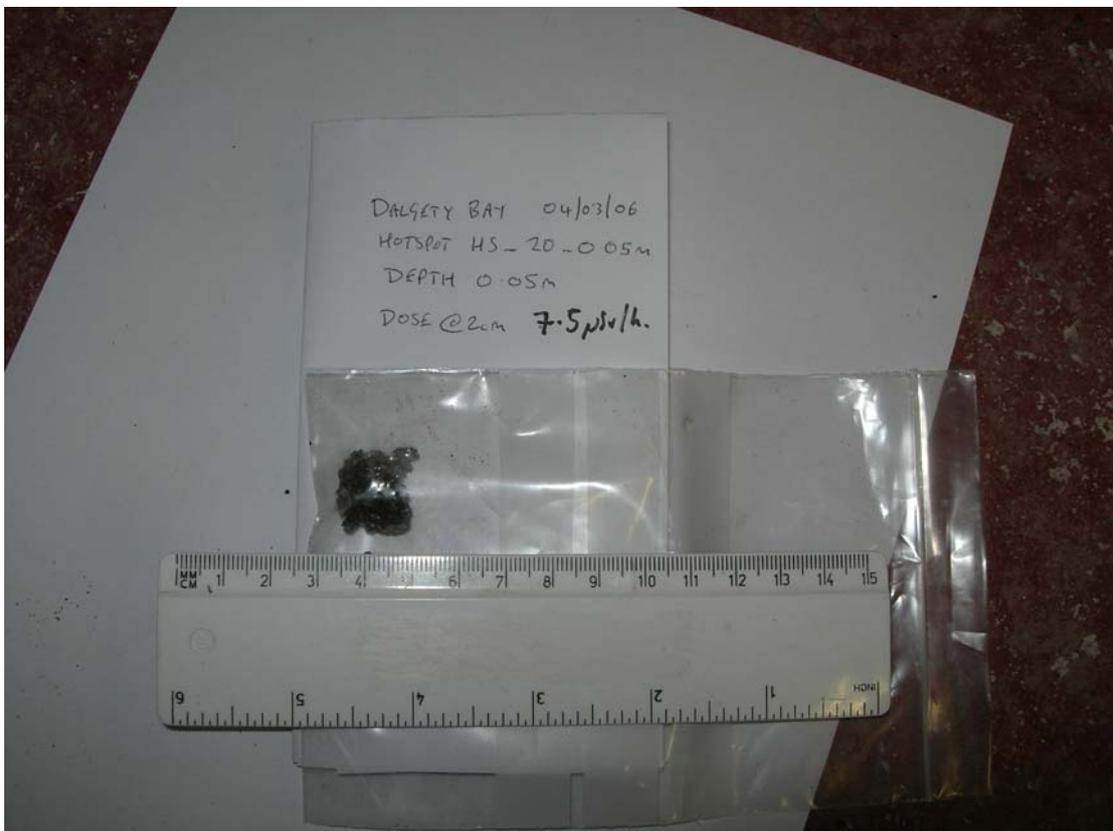
Hotspot 20

A coarse gravel fragment of clinker was found at a depth of 0.05m. Maximum dose rates at contact and 7.5cm were 0.5 and 0.6 μ Sv/h respectively. Direct 44B probe measurements were 3500cps.

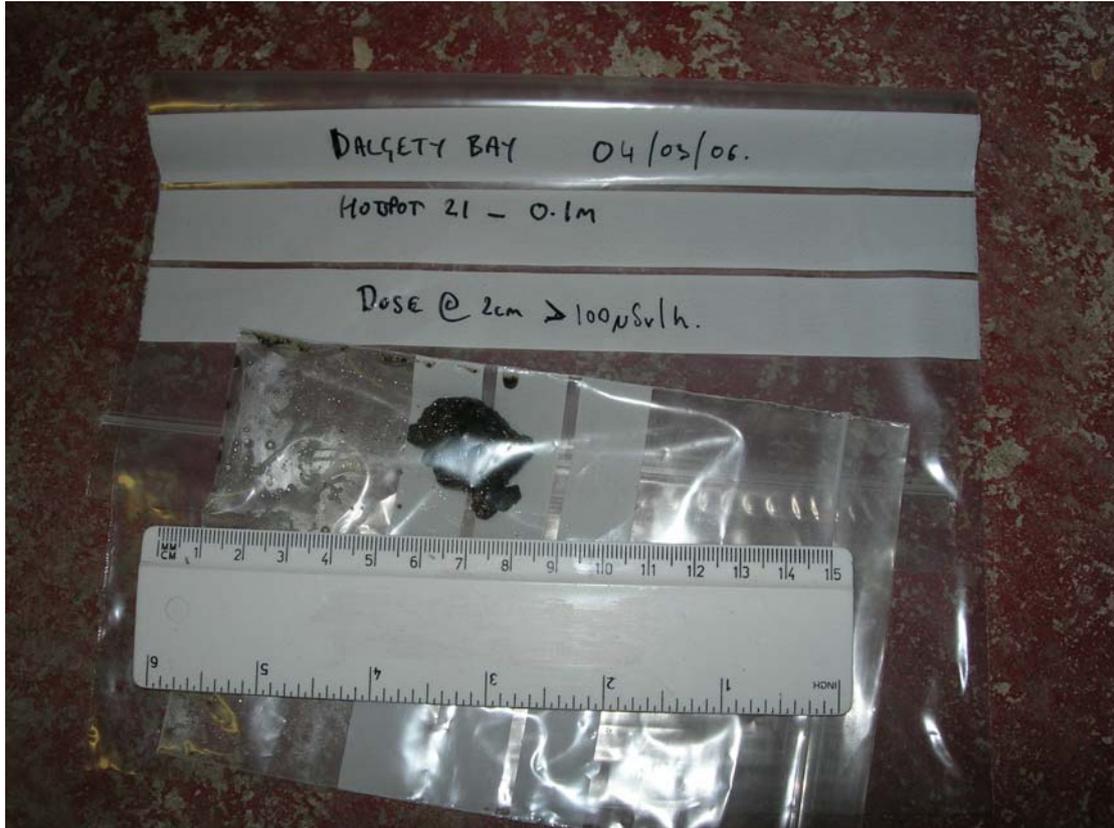
Hotspot 21

HS_21 comprised a coarse gravel sized piece of clinker located at a depth of 0.1m. Direct probe readings exceeded 5000cps. Maximum dose rates at contact and at 10cm were 150 and 6 μ Sv/h respectively.

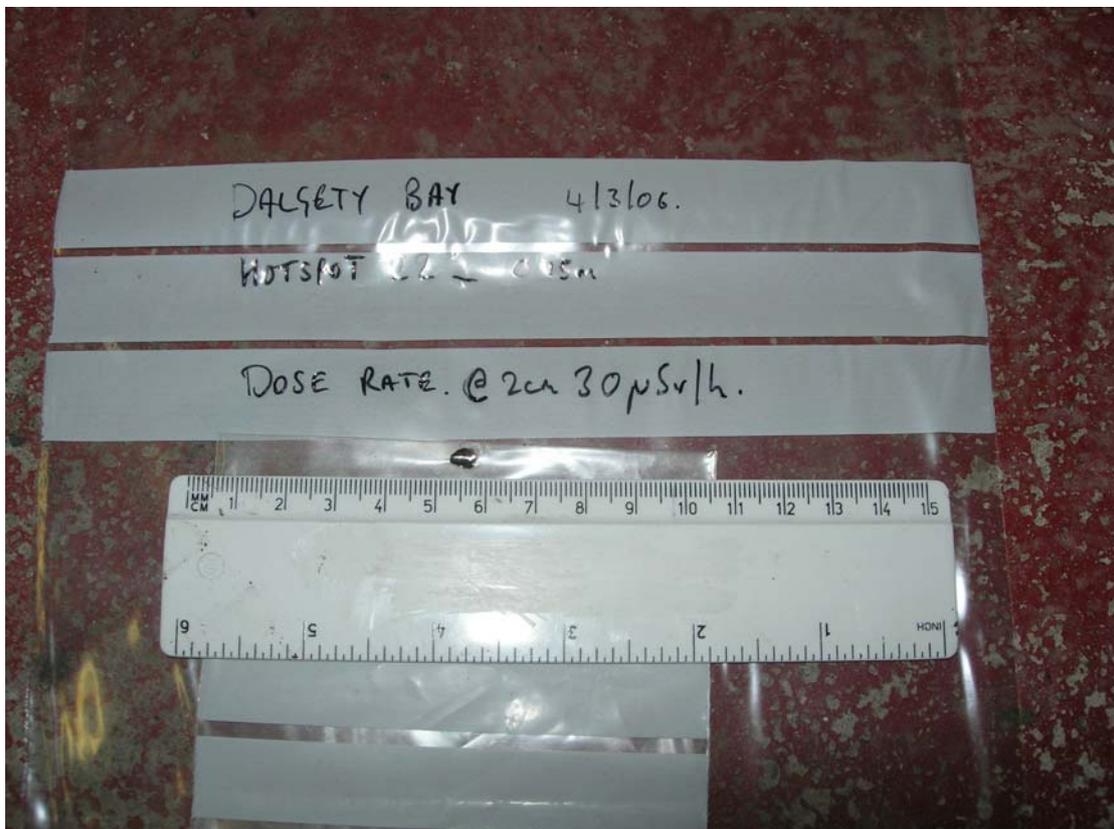
Hotspot 22

HS_22 was located at a depth of 0.15m and comprised fine gravel sized clinker. Maximum dose rates at contact and at 10cm were 30 and 1.5 μ Sv/h respectively. Direct probe readings of >5000cps were recorded.

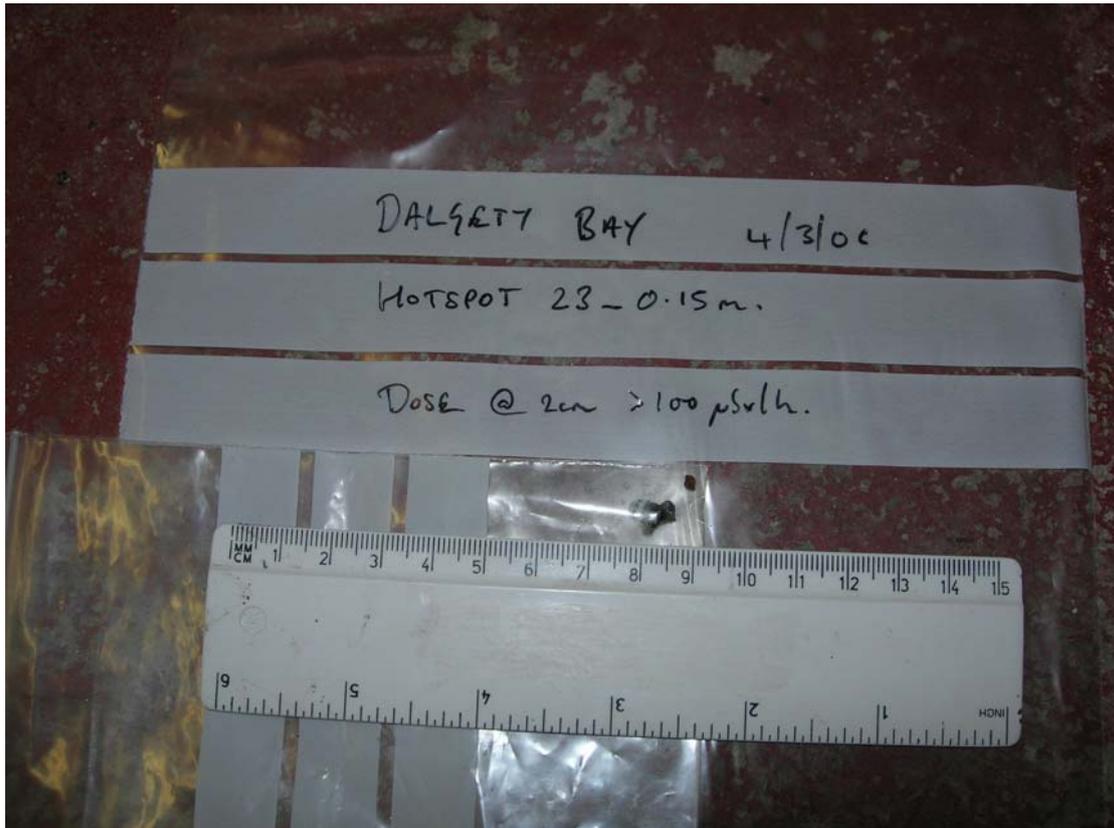
Hotspot 23

A clinker fragment of medium gravel size was found at 0.15m. Direct 44B probe measurements exceeded 5000cps. Maximum dose rates at contact and at 10cm were 125 and 5 μ Sv/h respectively.

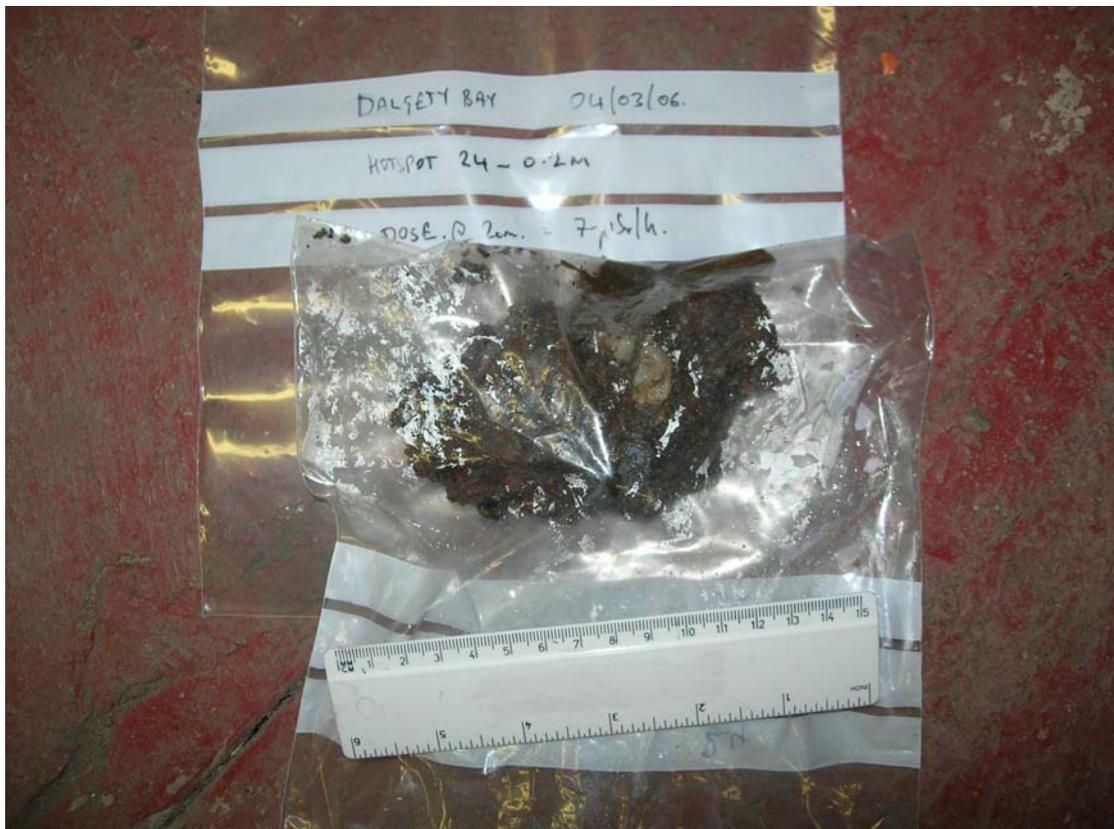
Hotspot 24

HS_24 was one of the largest pieces of contaminated material encountered at the site (cobble size) and was found at a depth of 0.2m. Maximum dose rates at contact and at 10cm were 7 and 1.5 μ Sv/h respectively. Direct probe readings of 2000cps were recorded.

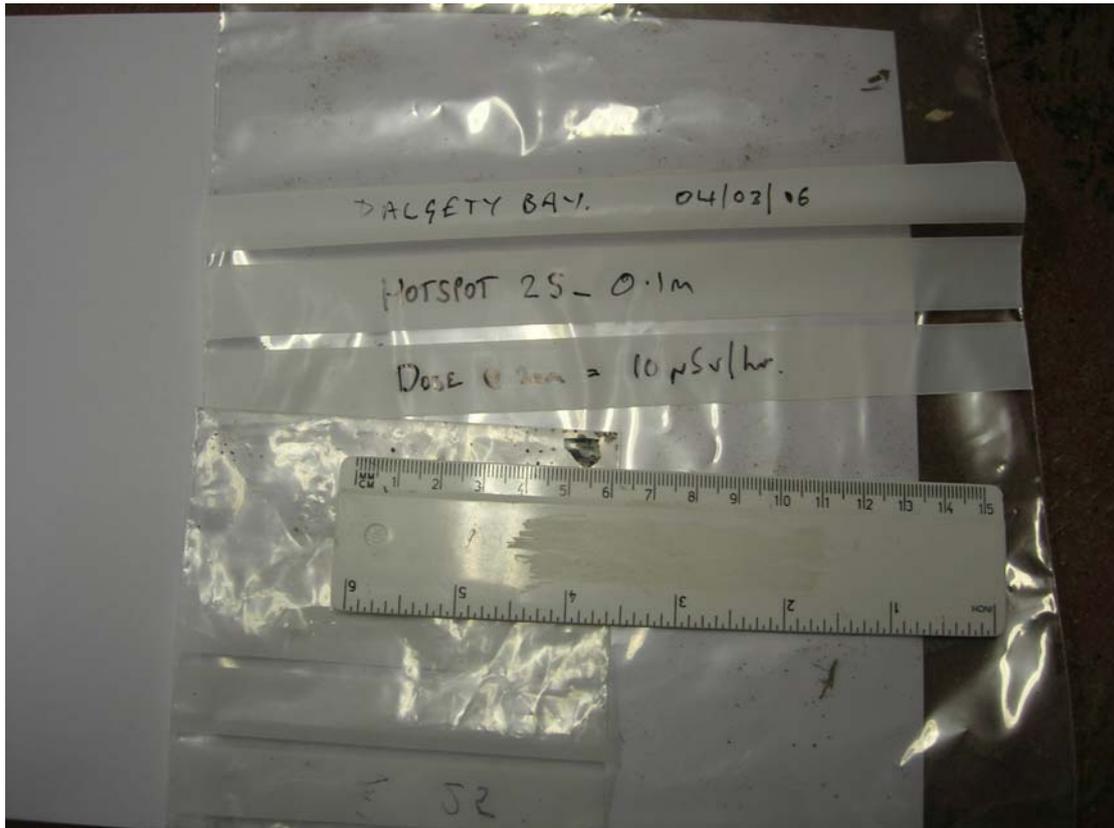
Hotspot 25

HS_25 (coarse sand) was located at a depth of 0.1m. Maximum dose rates at contact and at 10cm were 10 and 1 μ Sv/h respectively. Direct probe readings were greater than 5000cps.

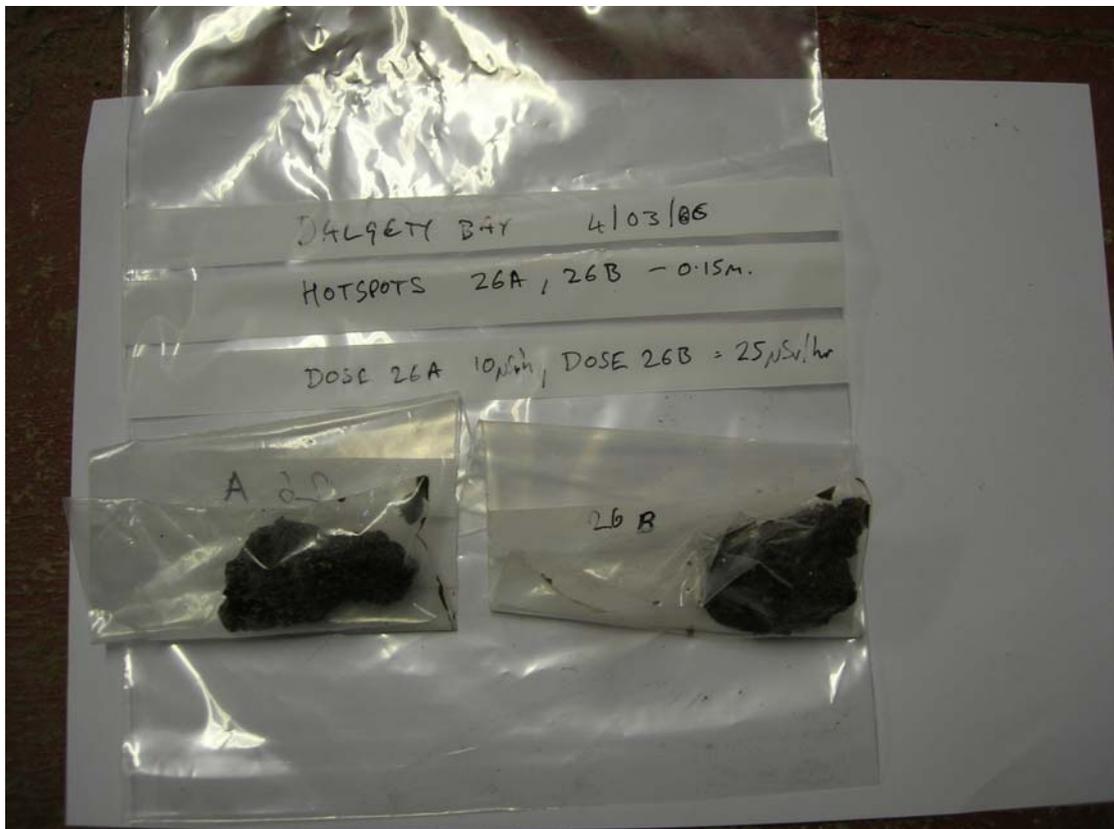
Hotspots 26A and 26B

Two items were located at 0.15m and were coarse gravel sized clinker. Maximum dose rates at contact and at 10cm were 10 and 1.5 μ Sv/h for item "A" and 25 and 3 μ Sv/h for item "B" respectively. Direct 44B probe readings were 4000cps and >5000cps for "A" and "B".

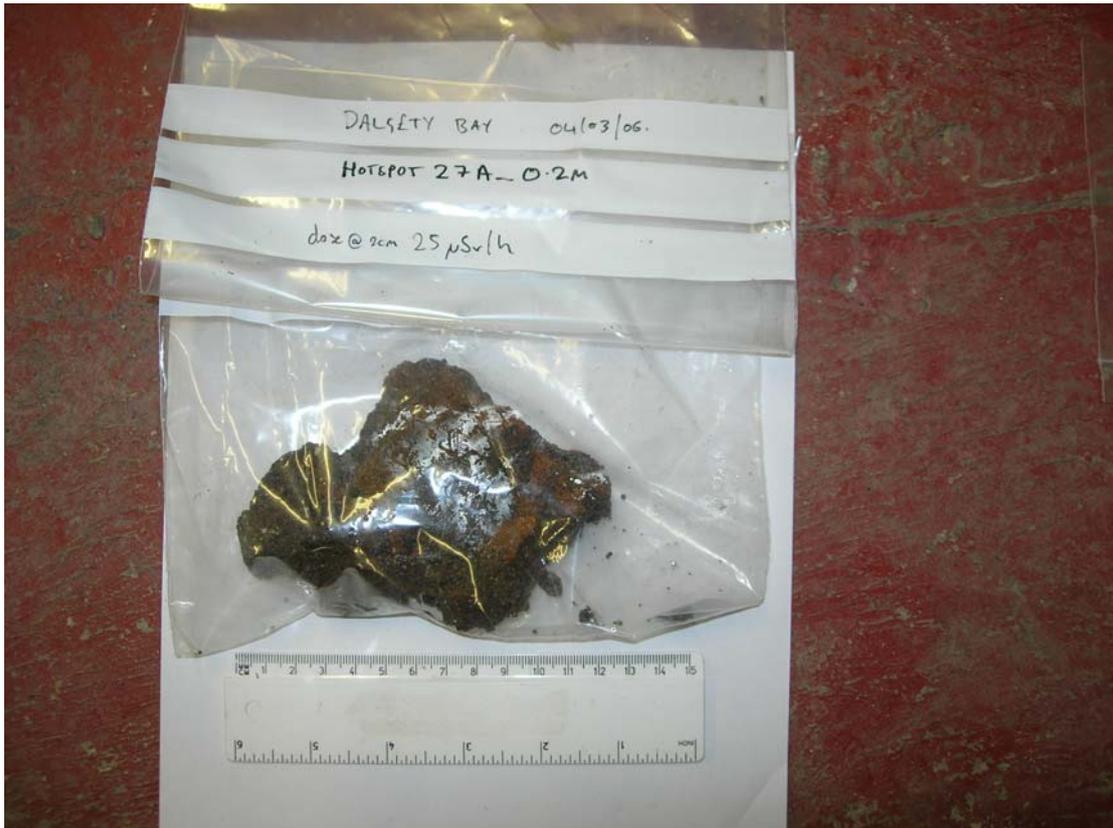
Hotspot 27A

Five separate items were collected at this location of a similar size (medium gravel) and all at a depth of 0.2m. Direct 44B probe readings for items A, B, C, D and E were >5000, 300, 1500, 3000 and 700cps respectively. Dose rate measurements are listed below:

Item	Dose (contact) μ Sv/h	Dose (10cm) μ Sv/h
A	25	2.5
B	0.6	0.15
C	2	0.3
D	3	0.6
E	1.5	0.4

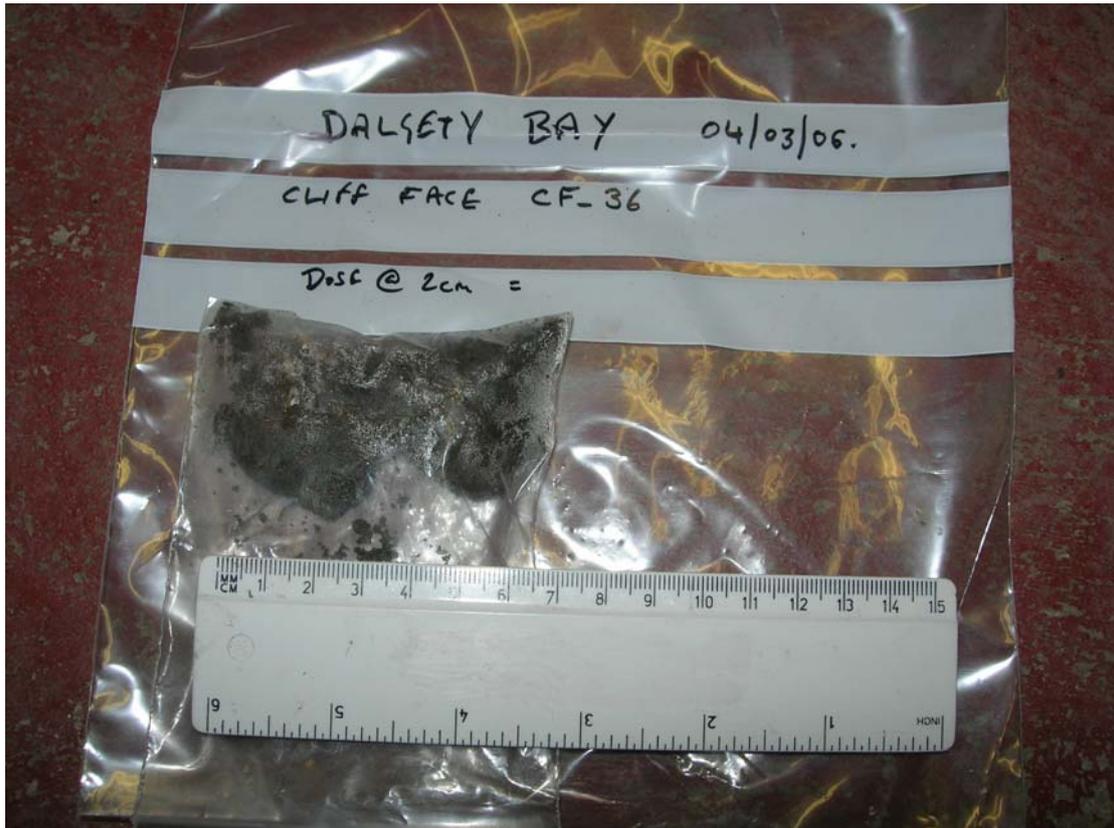
Hotspot (Cliff face) CF_36

This item was removed from the cliff face section and comprised a coarse gravel sized clinker fragment. It was located at a depth of 0.075m into the cliff face. Direct probe readings of 3000cps were recorded on the item. Maximum dose rates at contact and at 10cm were 15 and 2 μ Sv/h respectively.

CF36 Elevated activity detected at ~0.75m (cps, 44B probe 25) contaminated items removed (see artefact log)

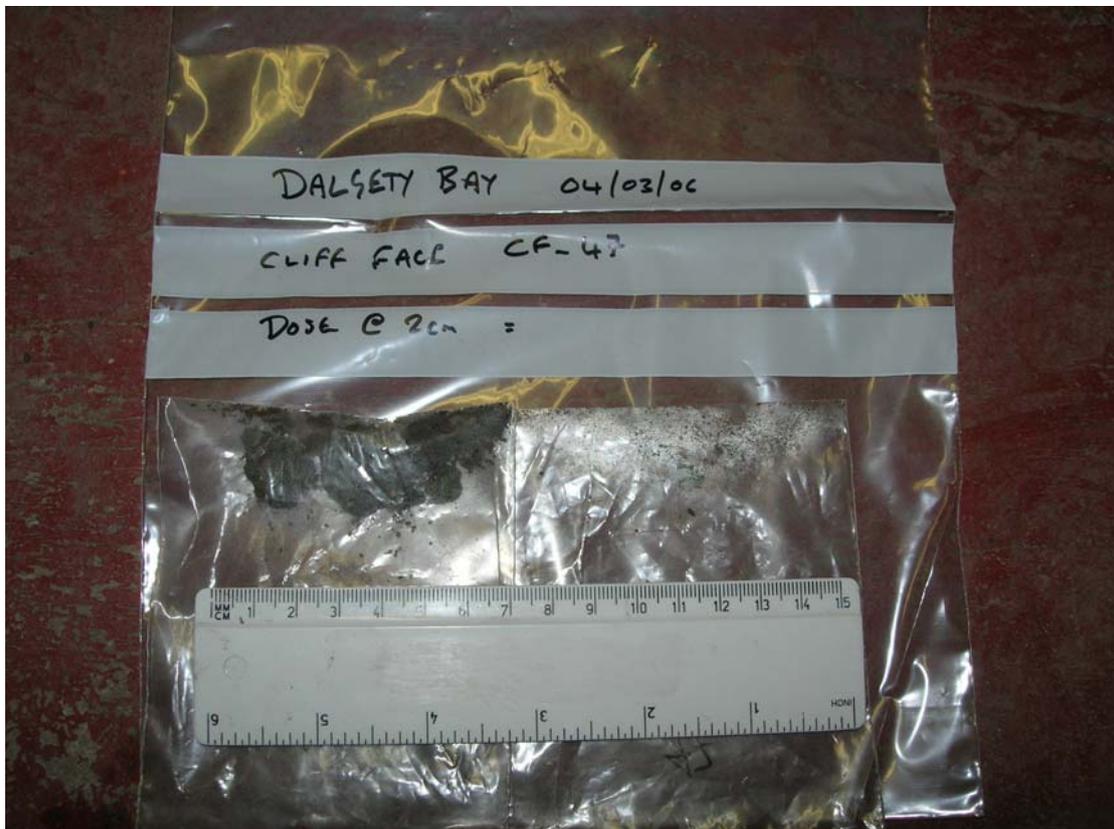
Hotspot (Cliff face) CF_47

Material removed from this section of the cliff face was fine material including some green coloured (paint?) flakes which could not be segregated further. Maximum dose rates at contact and at 10cm were 3 and 0.7 μ Sv/h respectively. Maximum probe readings taken on the bagged material were 1500cps.

CF47 Elevated activity detected at ~0.5m (cps, 44B probe 100) contaminated items removed (see artefact log)
