Dalgety Bay

Appropriate Person Report

Appendix 16

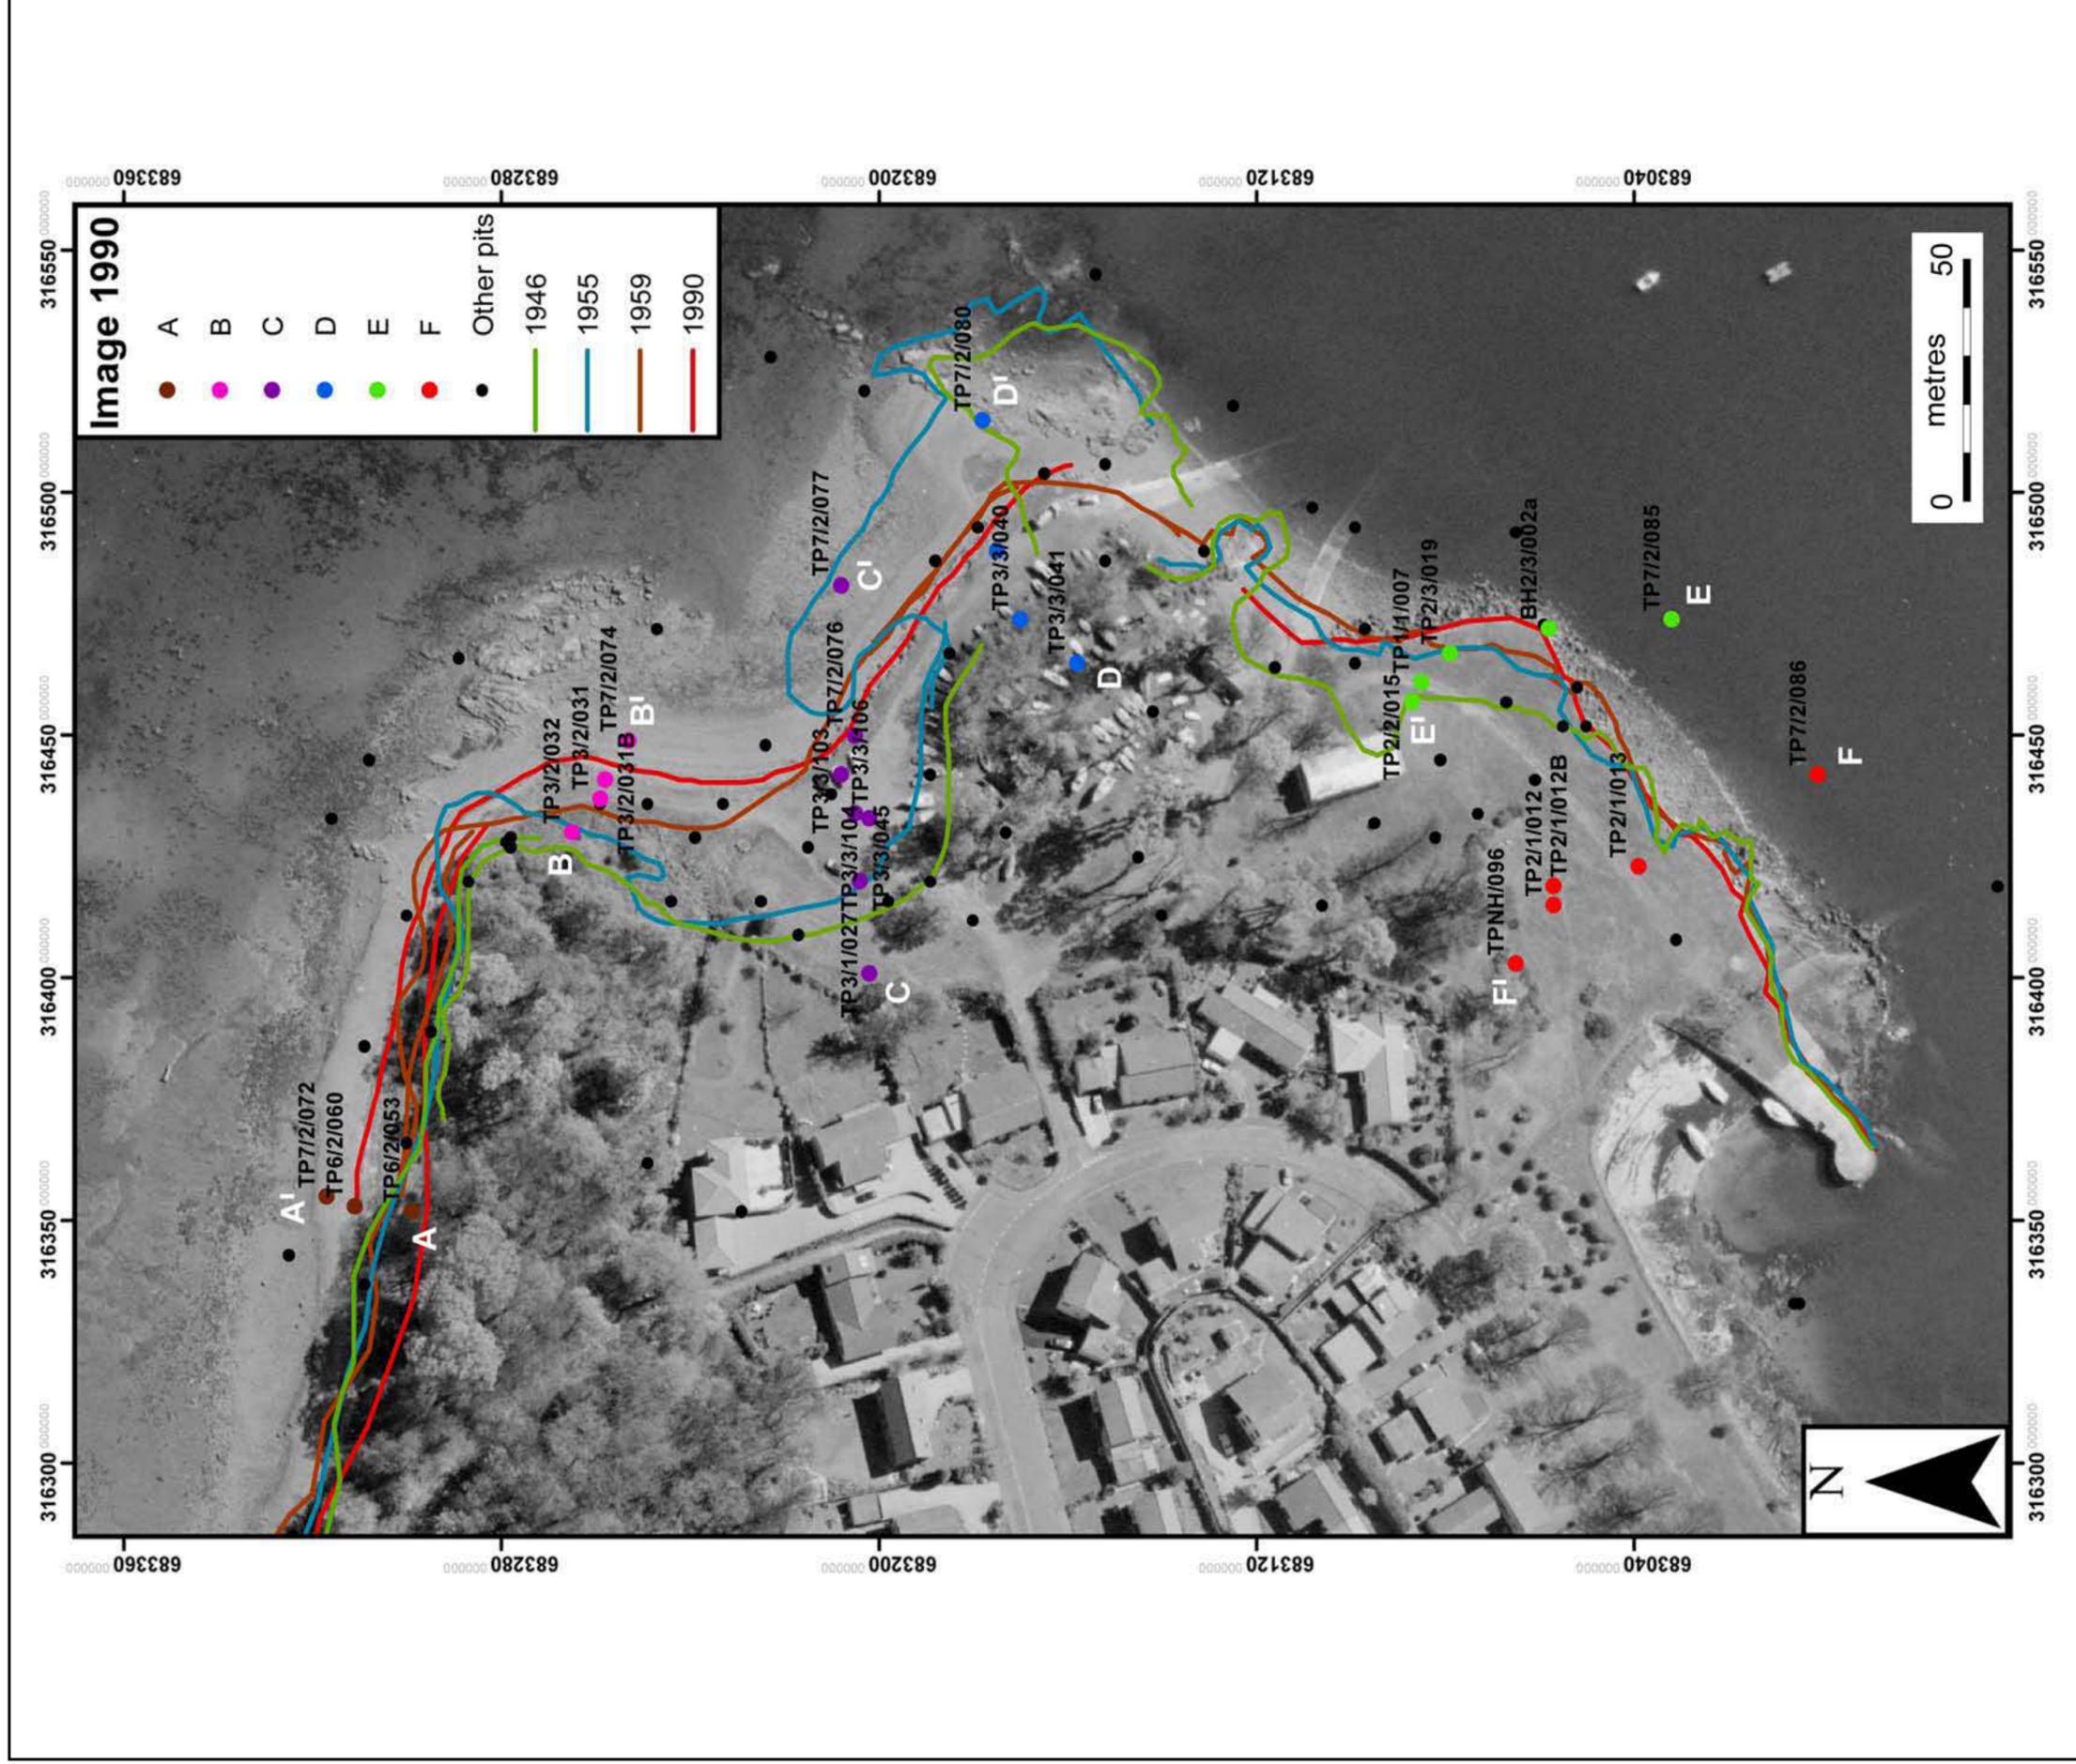
Figure B0

Cross section lines and trial pit/borehole locations after AMEC Factual Investigation Report 2013.
Coastlines after Sneddon et al, 2013.

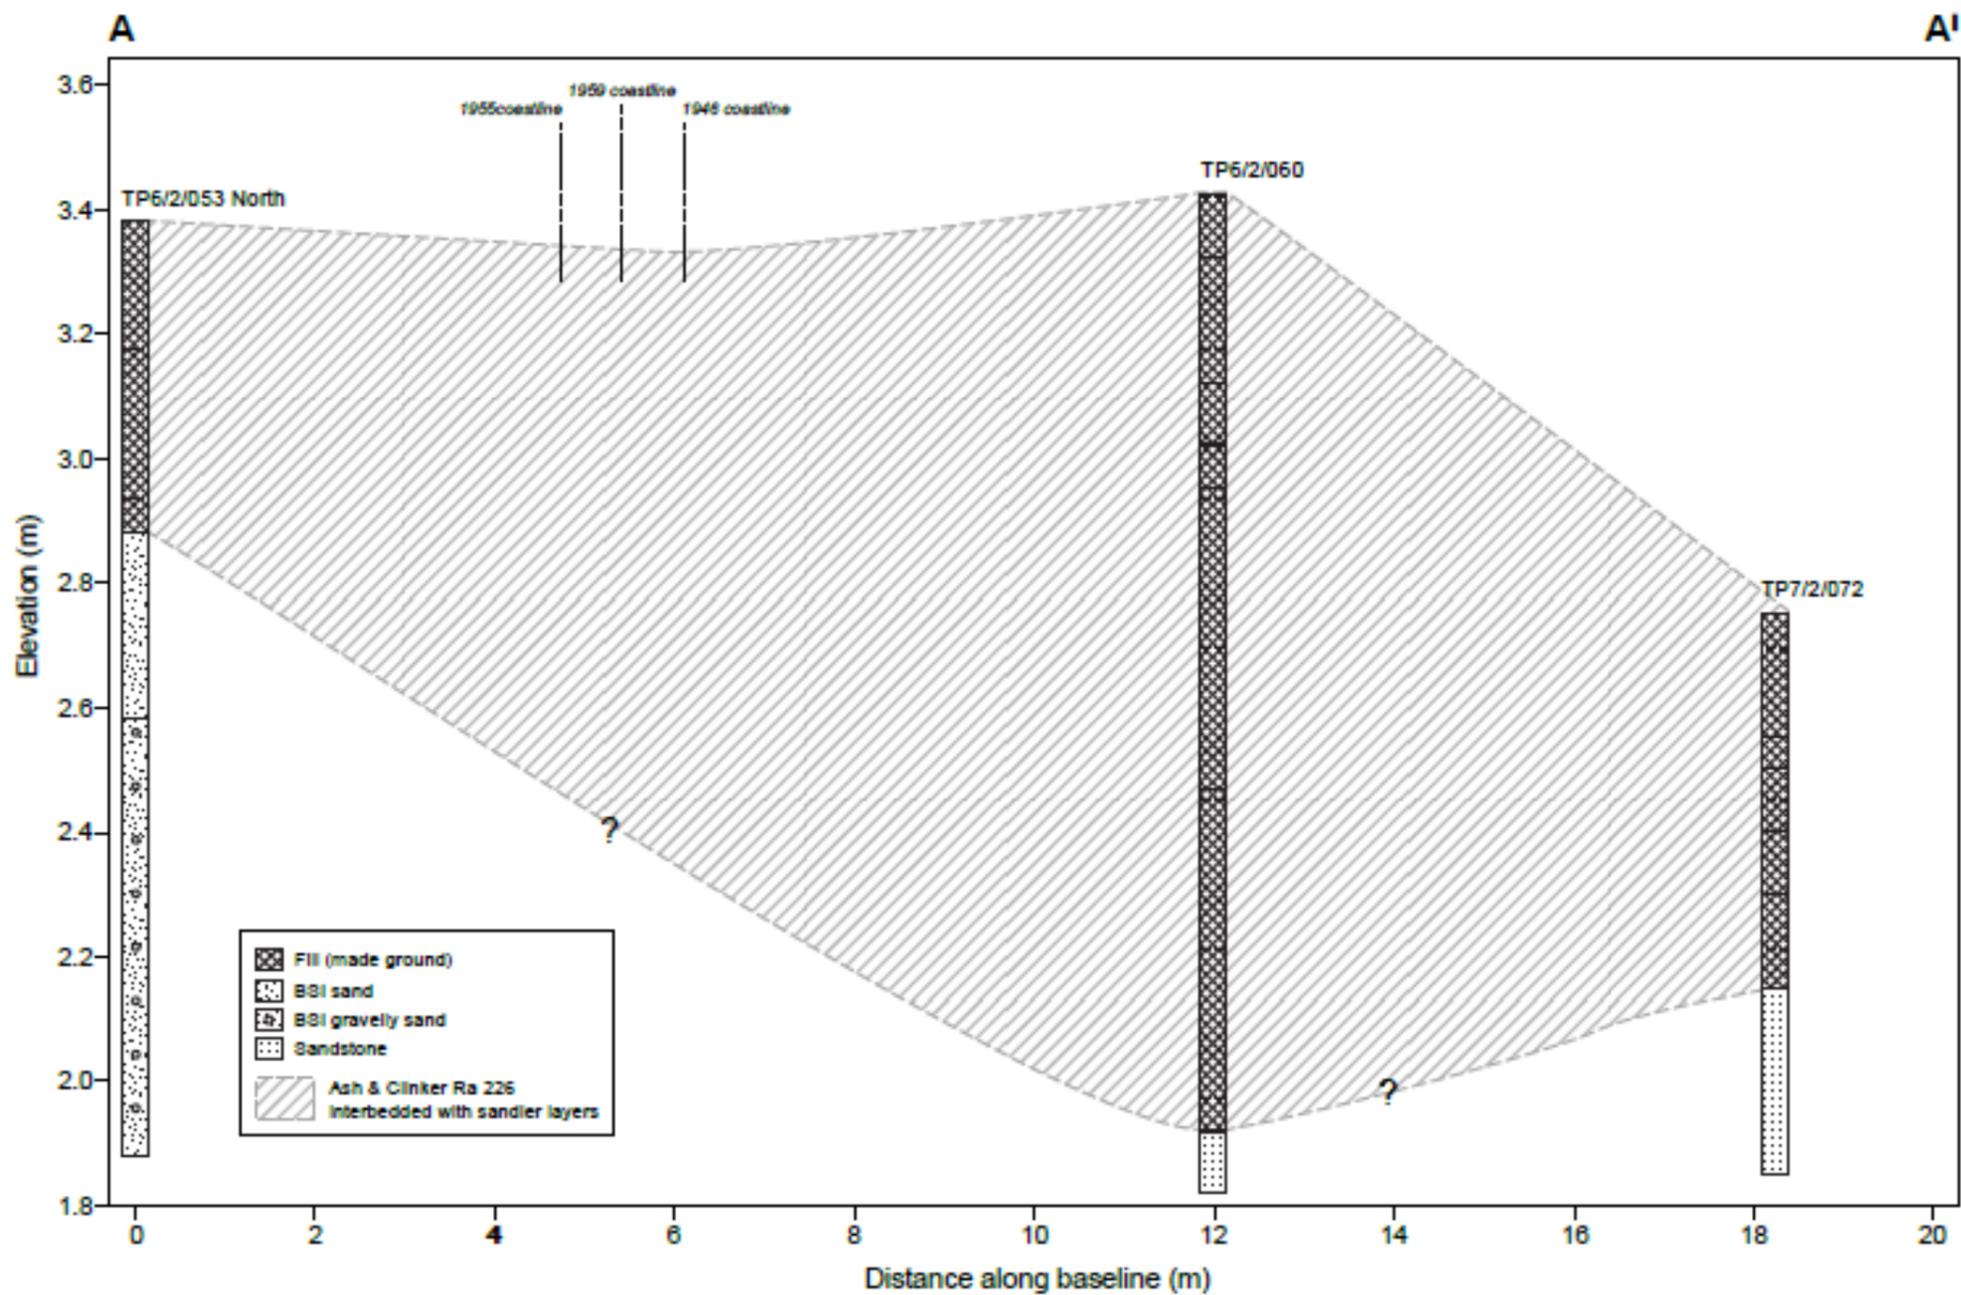
Figure B1

Cross section line and trial pit/borehole logs after AMEC Factual Investigation Report 2013.

Coastline locations after Sneddon et al, 2013.

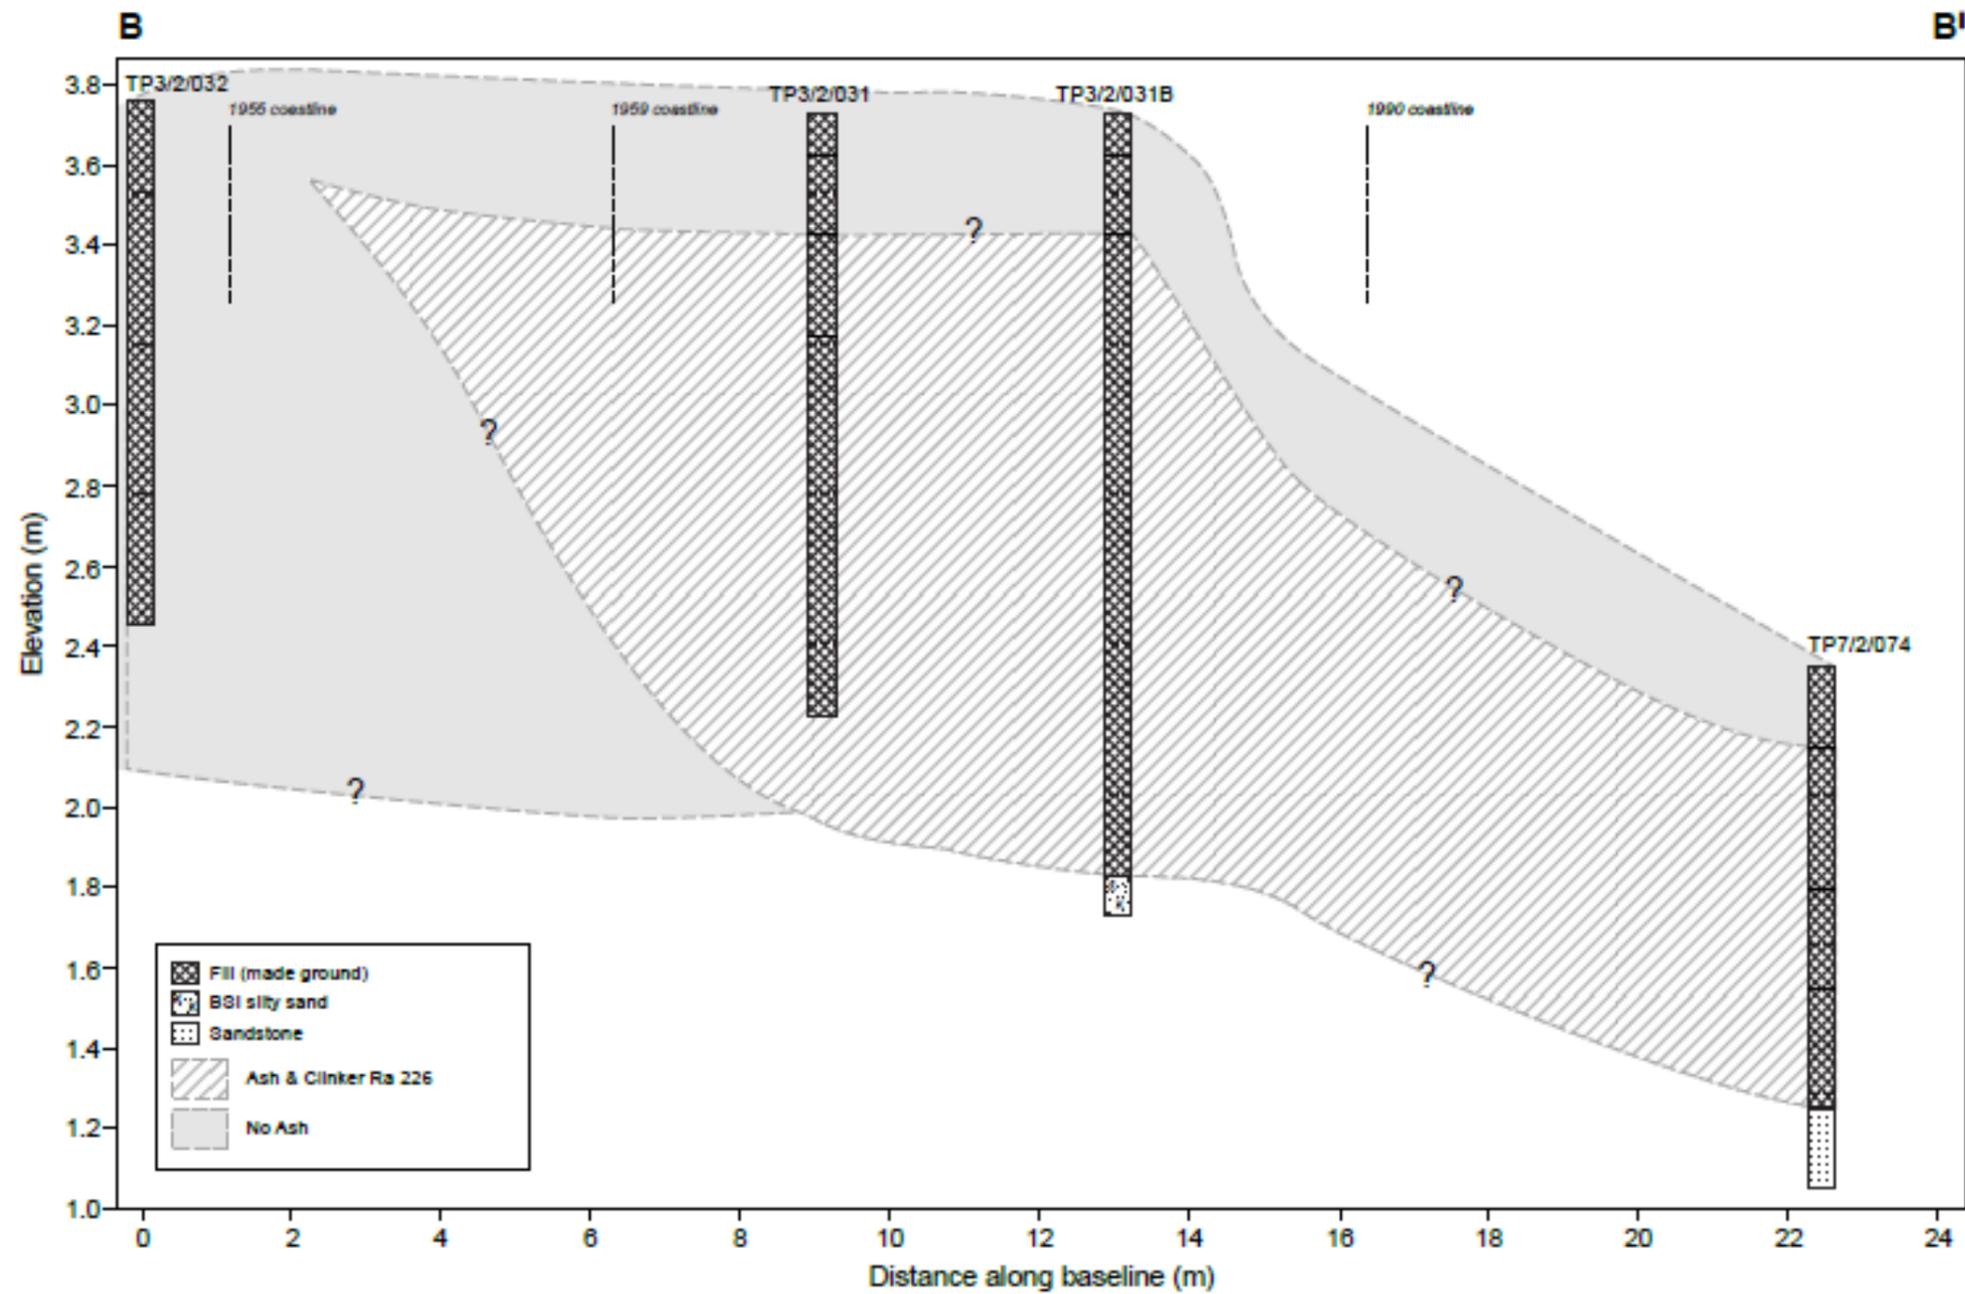
Figure B3

Cross section line and trial pit/borehole logs after AMEC Factual Investigation Report 2013.

Coastline locations after Sneddon et al, 2013.

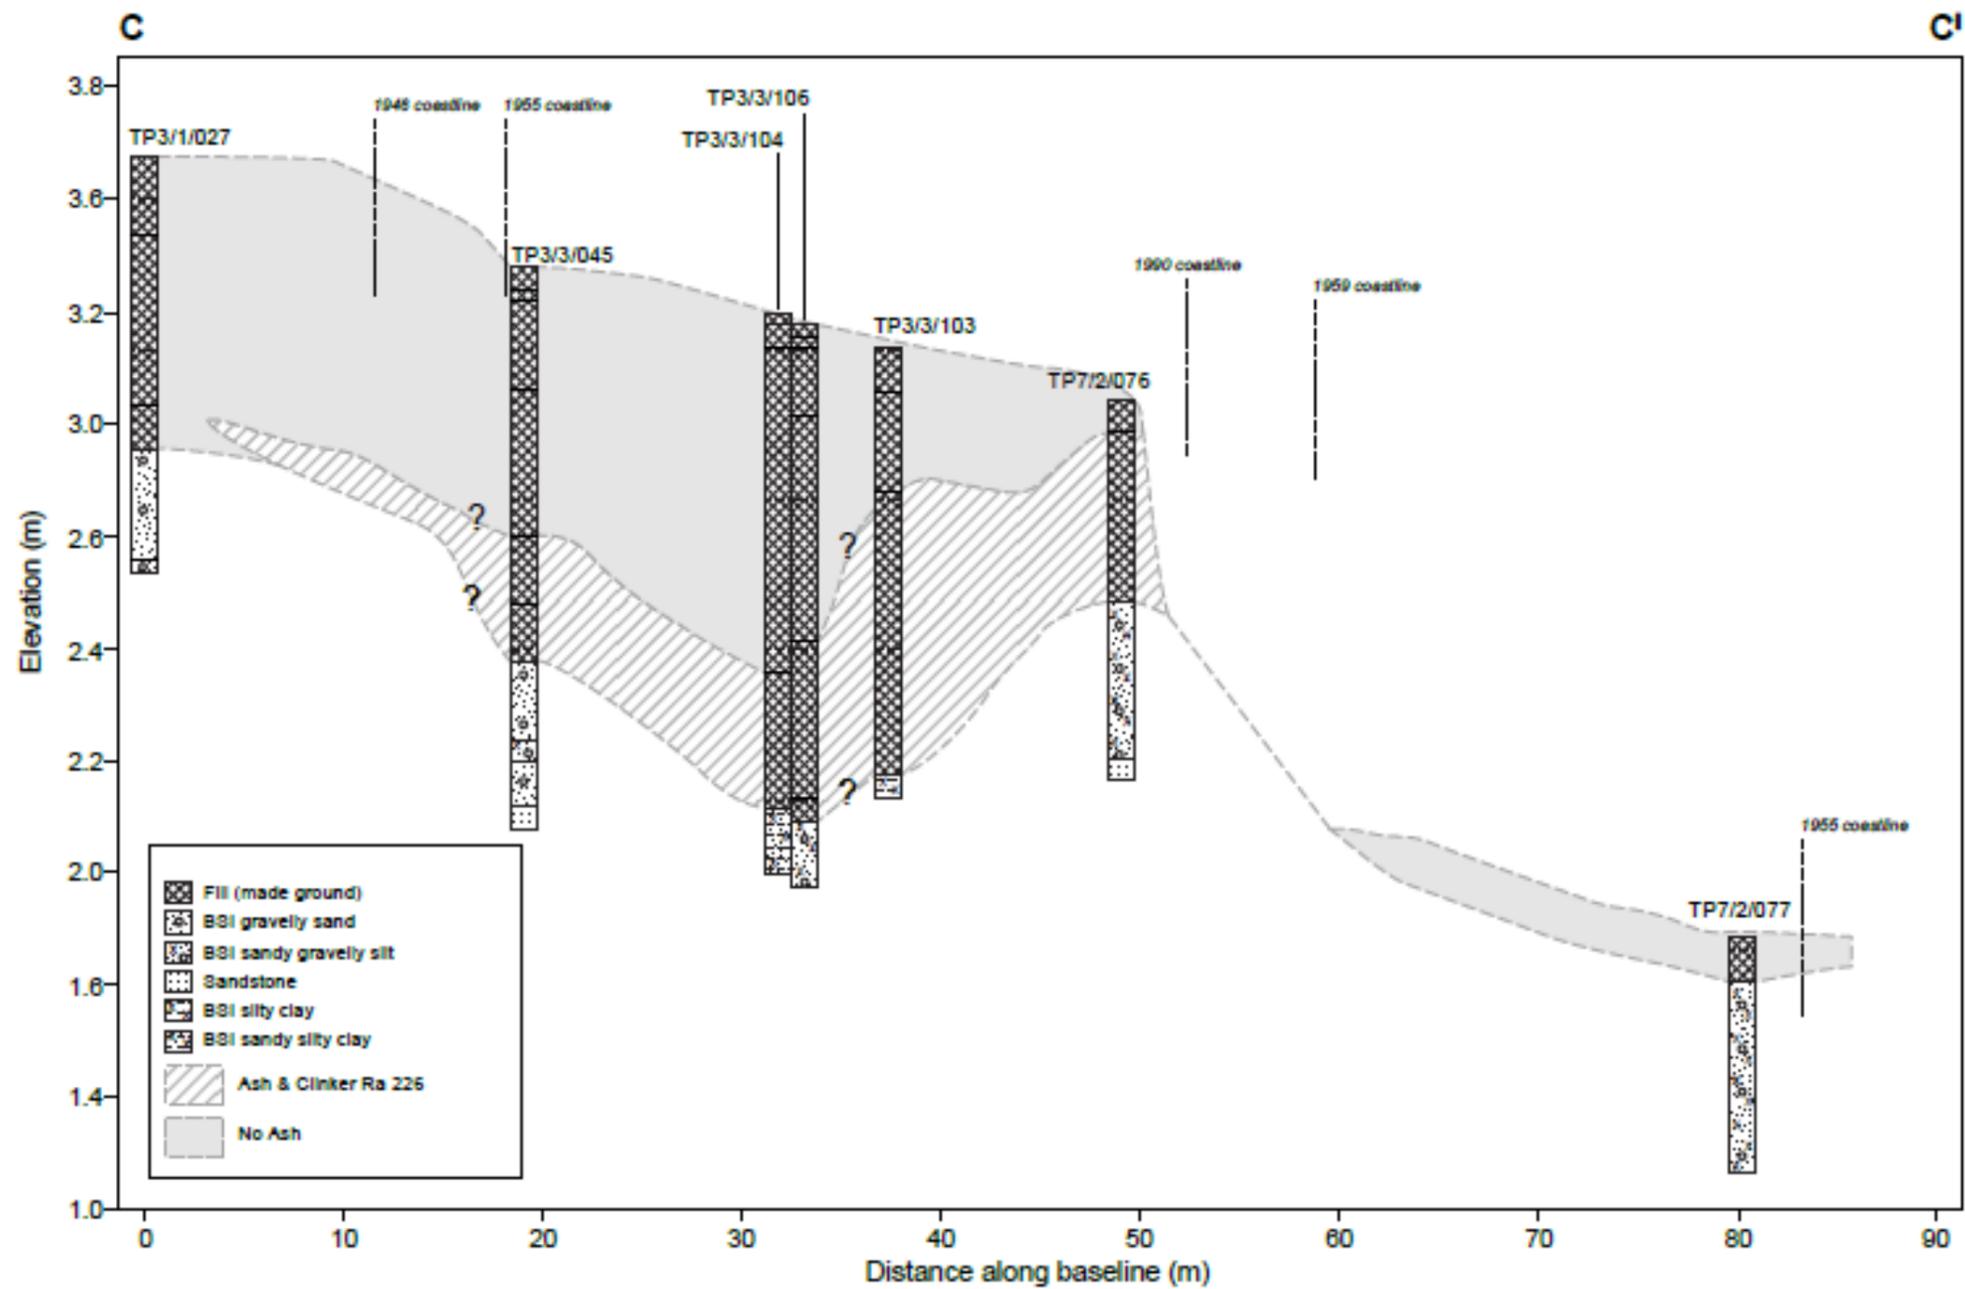
Figure B2

Cross section line and trial pit/borehole logs after AMEC Factual Investigation Report 2013.

Coastline locations after Sneddon et al, 2013.

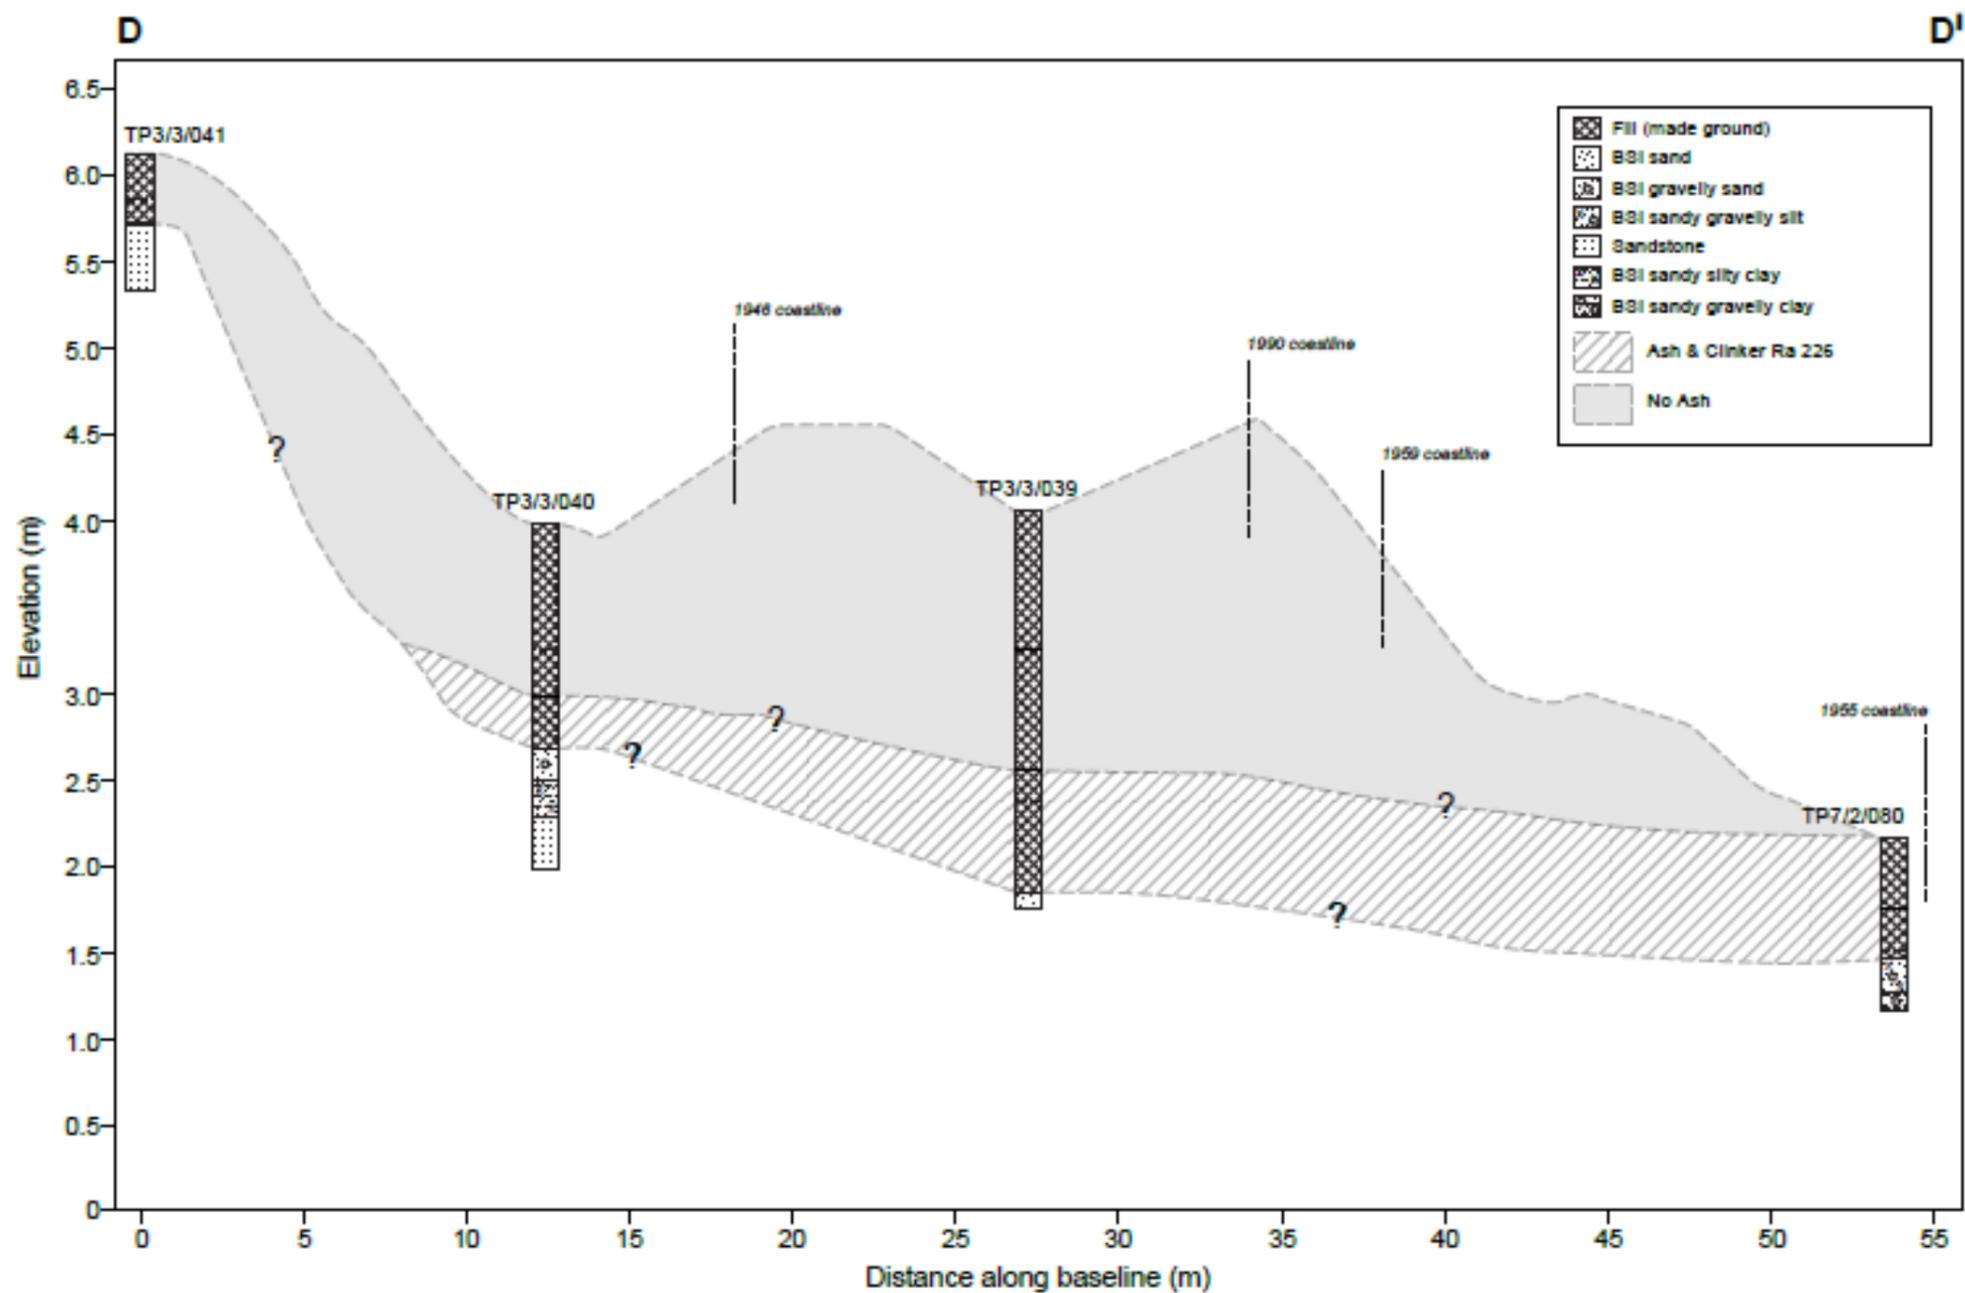
Figure B4

Cross section line and trial pit/borehole logs after AMEC Factual Investigation Report 2013.

Coastline locations after Sneddon et al, 2013.

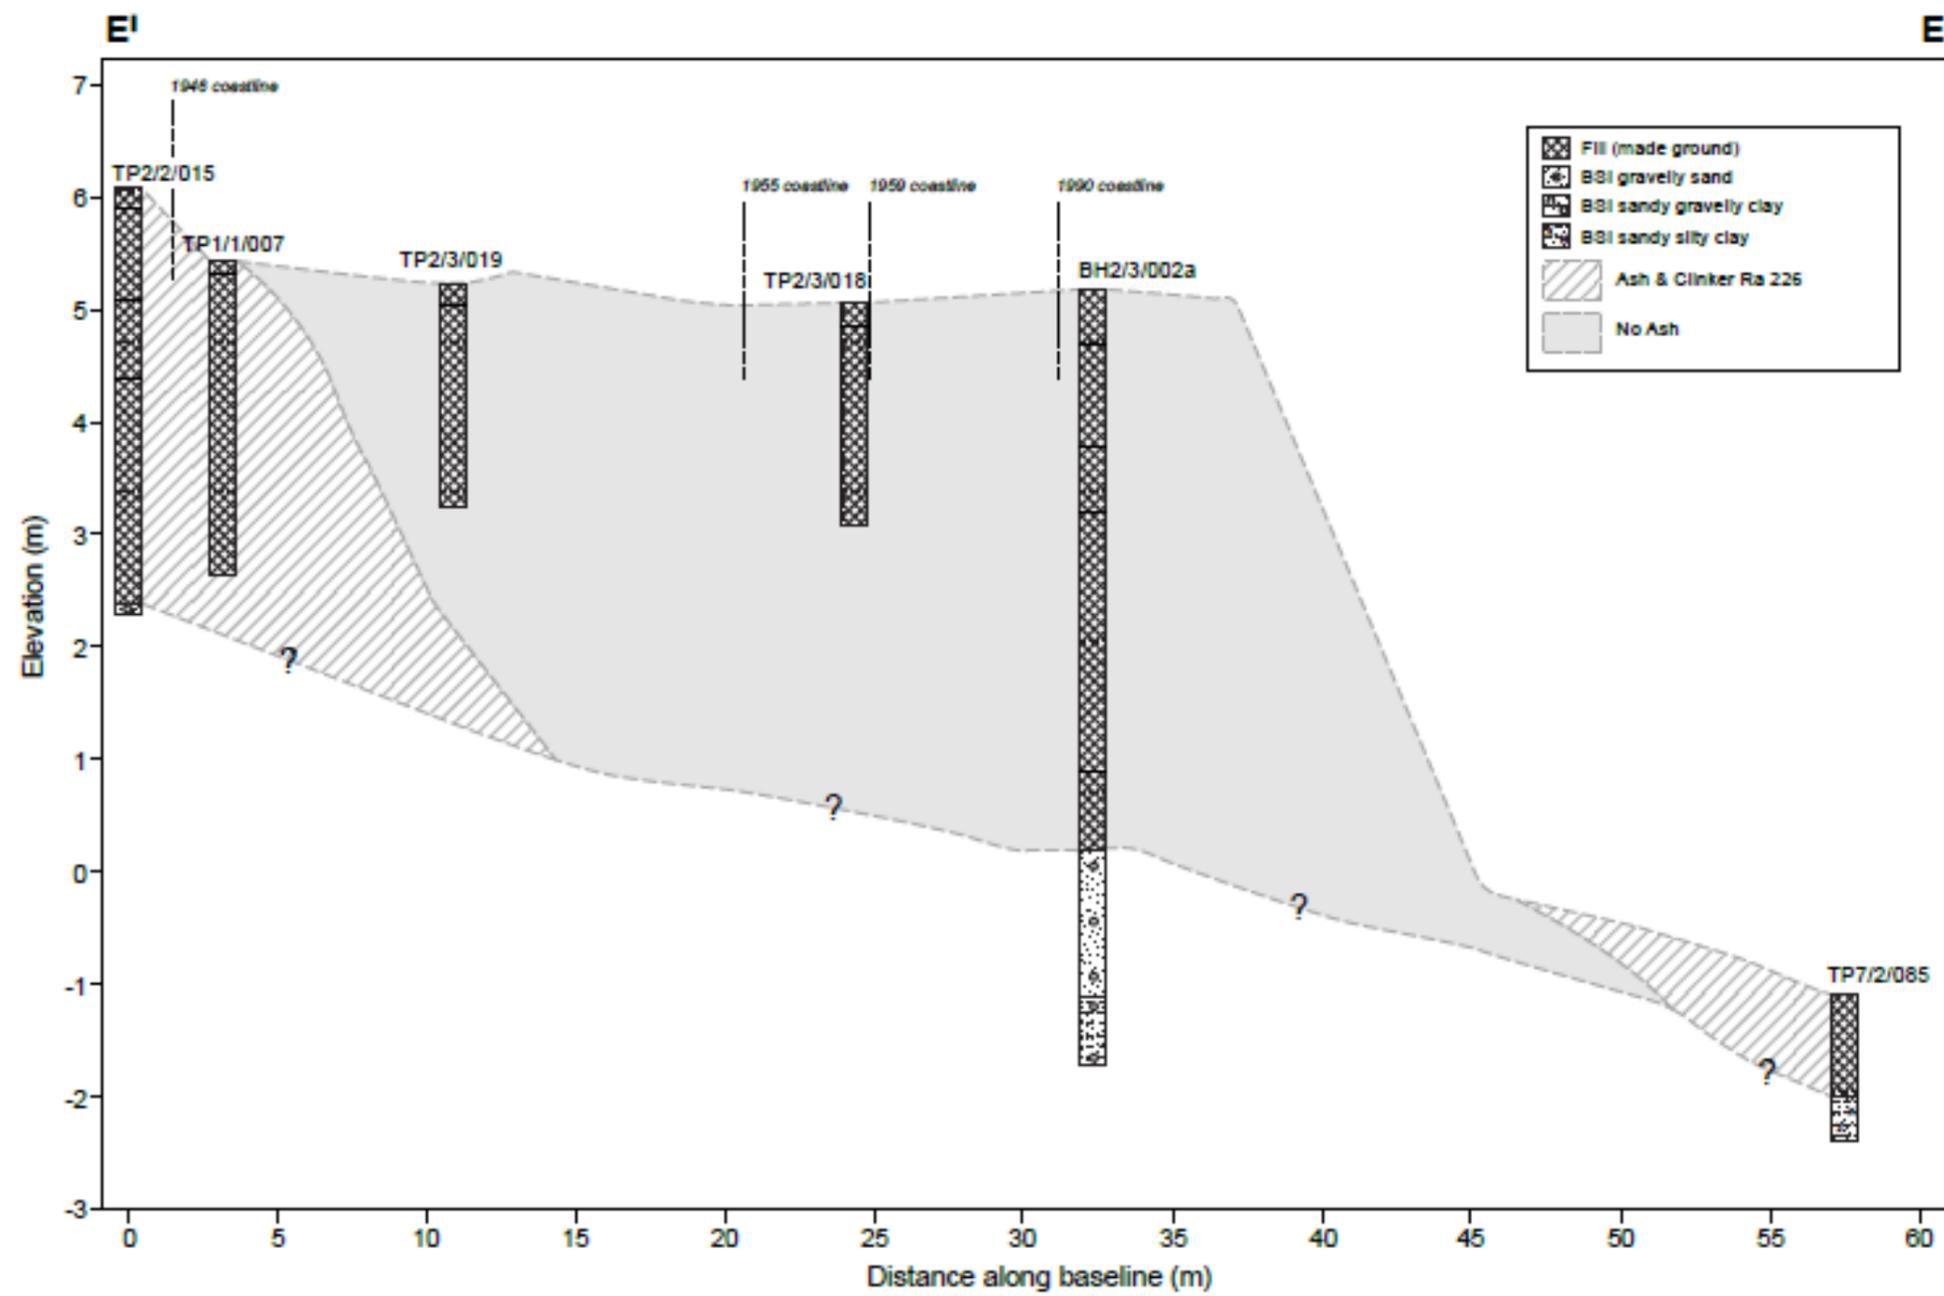
Figure B5

Cross section line and trial pit/borehole logs after AMEC Factual Investigation Report 2013.

Coastline locations after Sneddon et al, 2013.

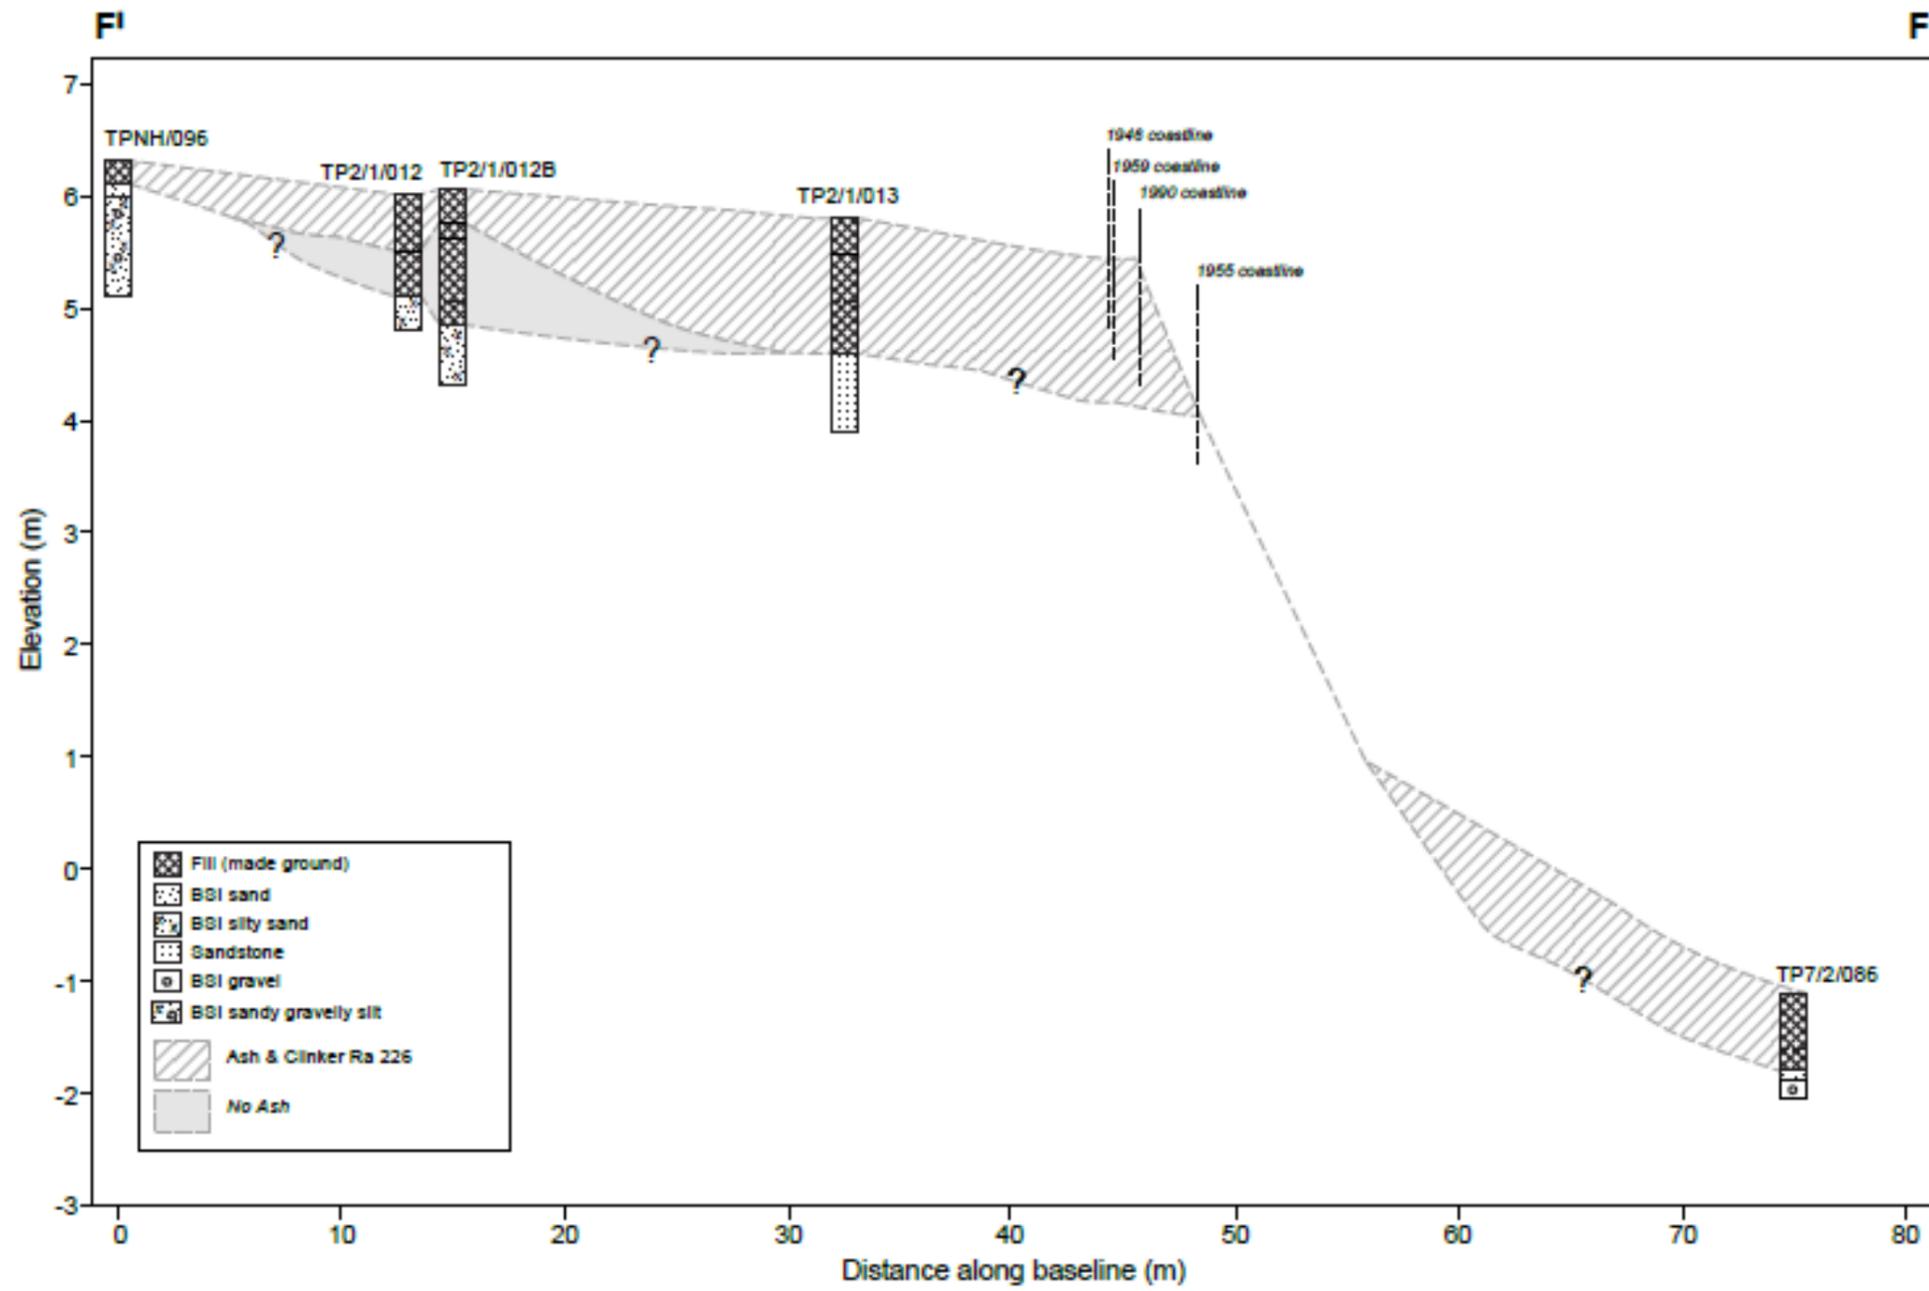
Figure B6

Cross section line and trial pit/borehole logs after AMEC Factual Investigation Report 2013.

Coastline locations after Sneddon et al, 2013.
